INSPECTION REPORT

HIDDEN LAKE DAM CT DEEP #06107

HIDDEN LAKE ROAD
TRIBUTARY TO POND MEADOW BROOK
HADDAM, CONNECTICUT

MAY 2022

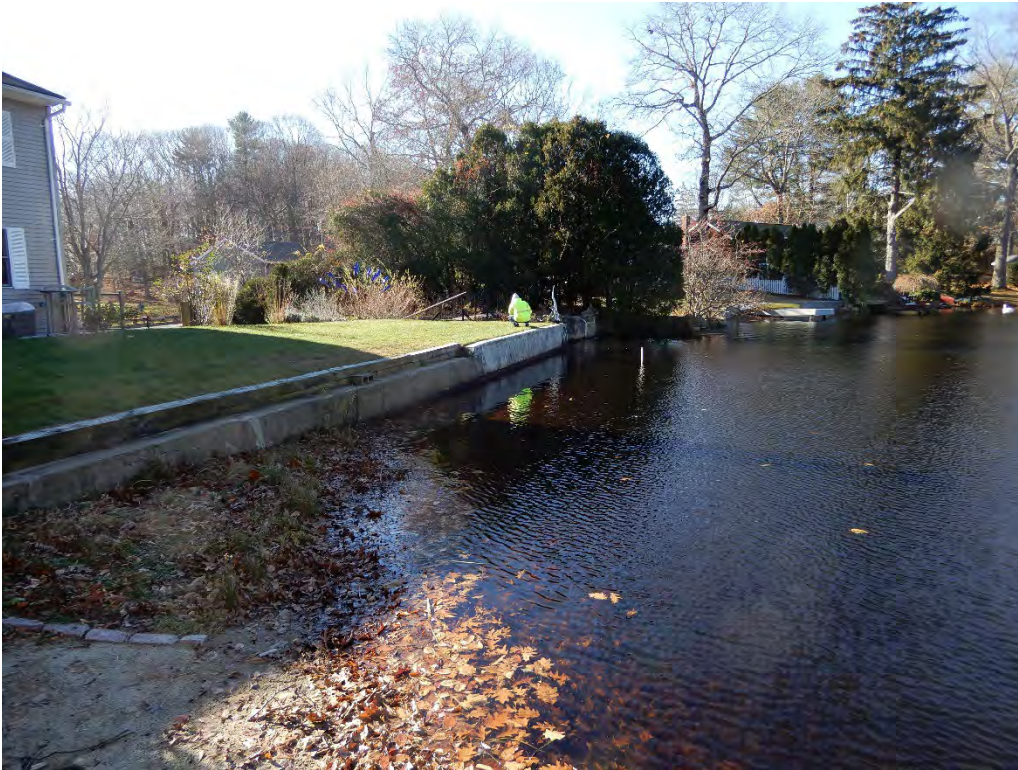
Photo 1a – An upstream overview of the dam, taken from the left side shoreline.

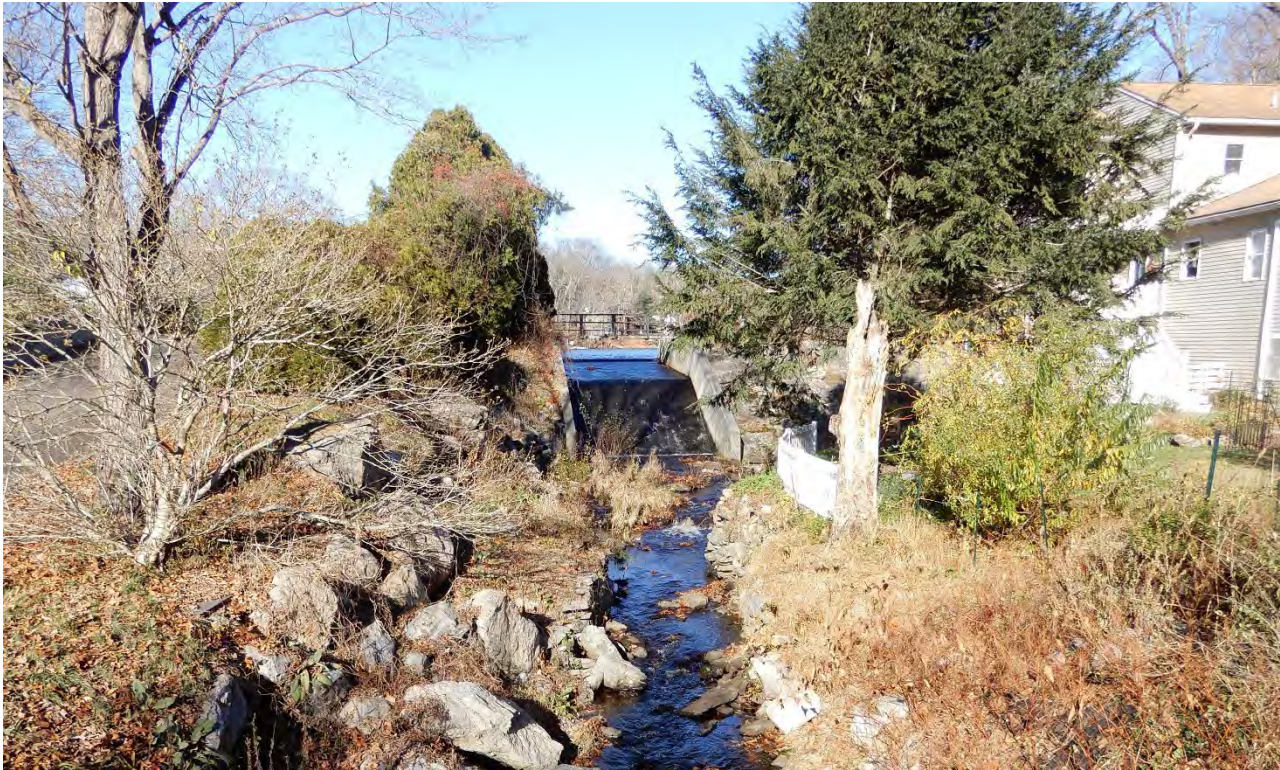
Photo 2a – An overview of the dam from downstream at the bridge crossing at Hidden Lake Road.

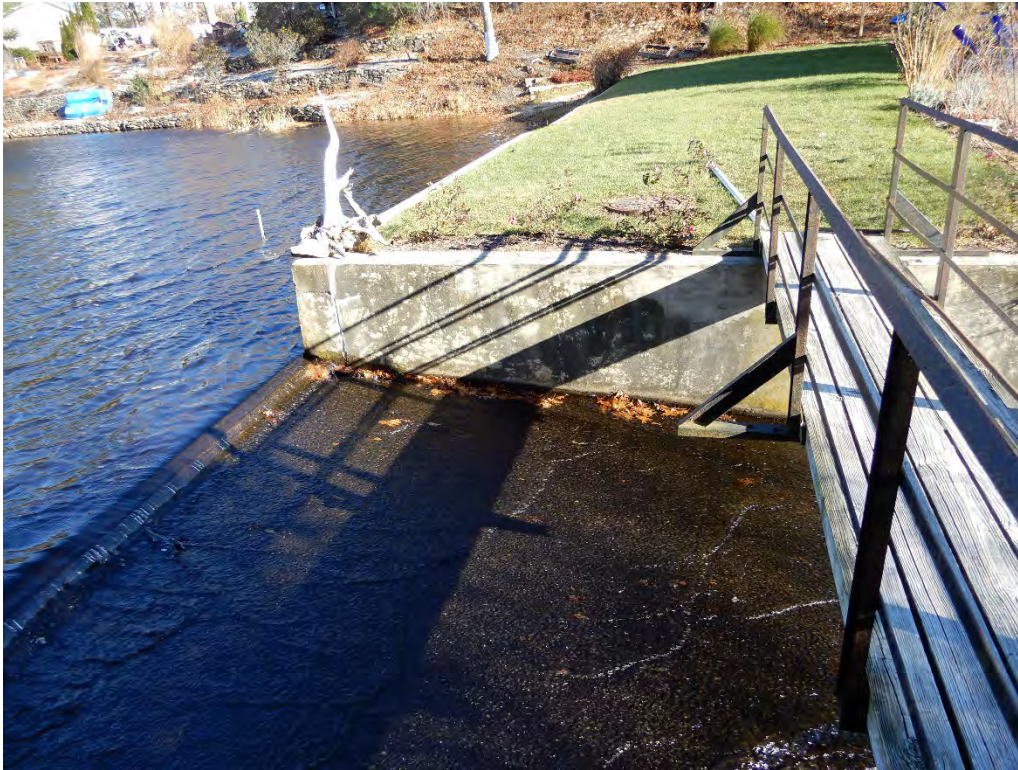
Photo 3 – The upstream side of the dam as seen from the right side.

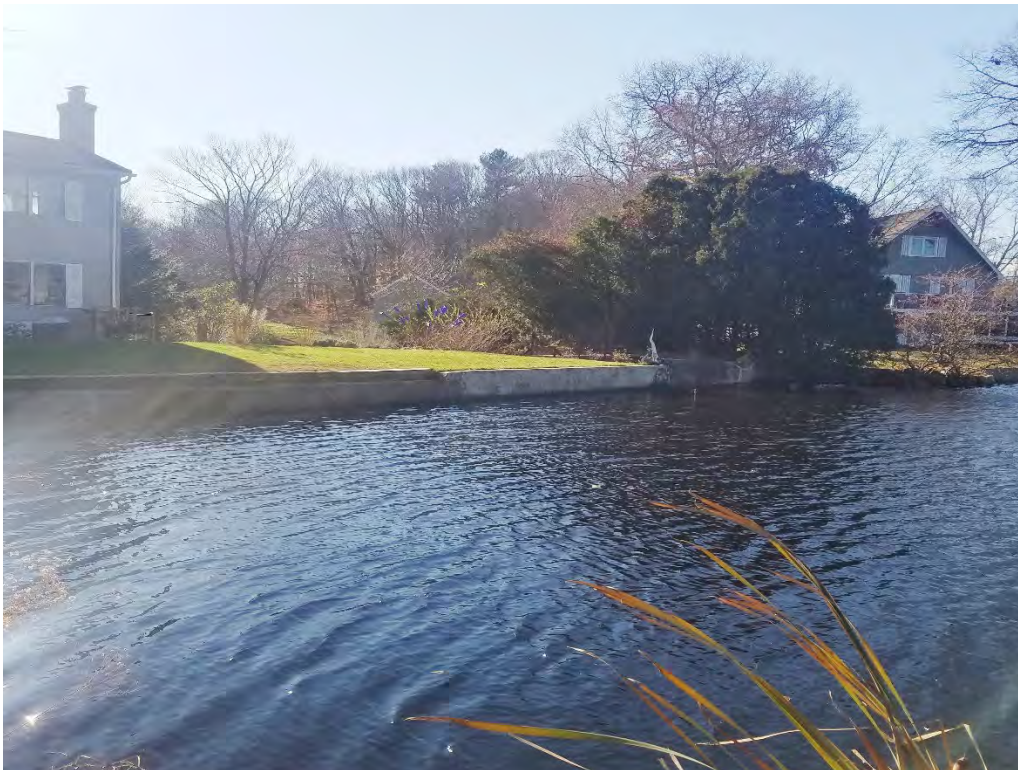
Photo 4a – The upstream side of the dam as viewed from near its left side abutment area.

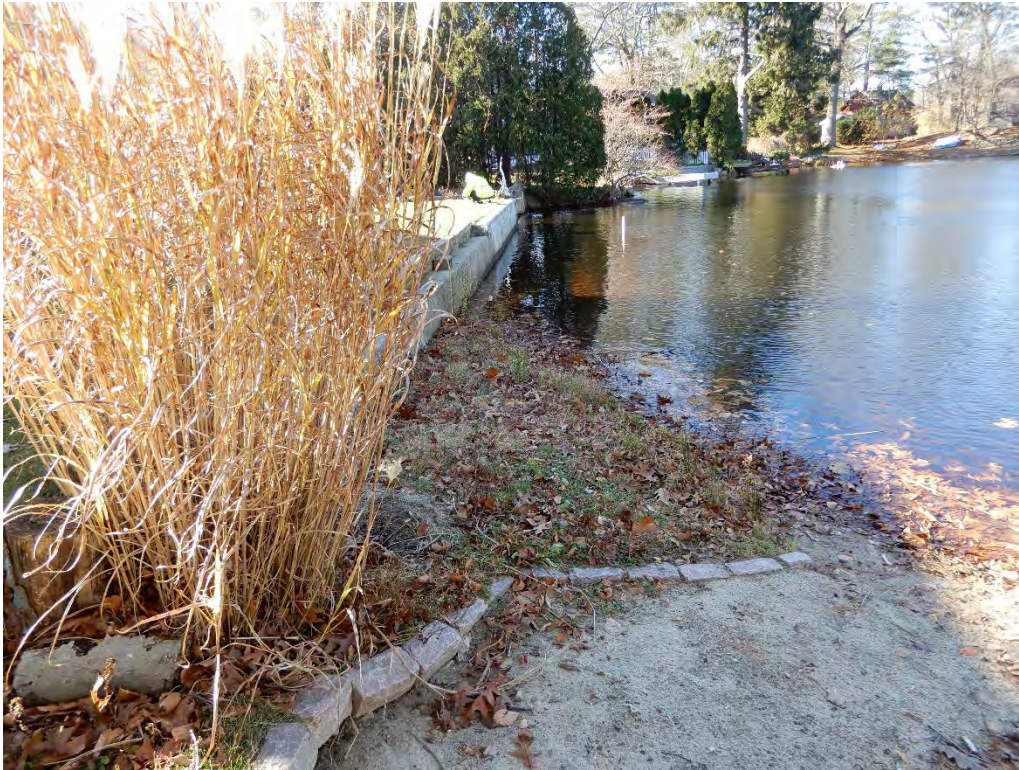
Photo 4b – The upstream shoreline of the dam, seen from the left side abutment.

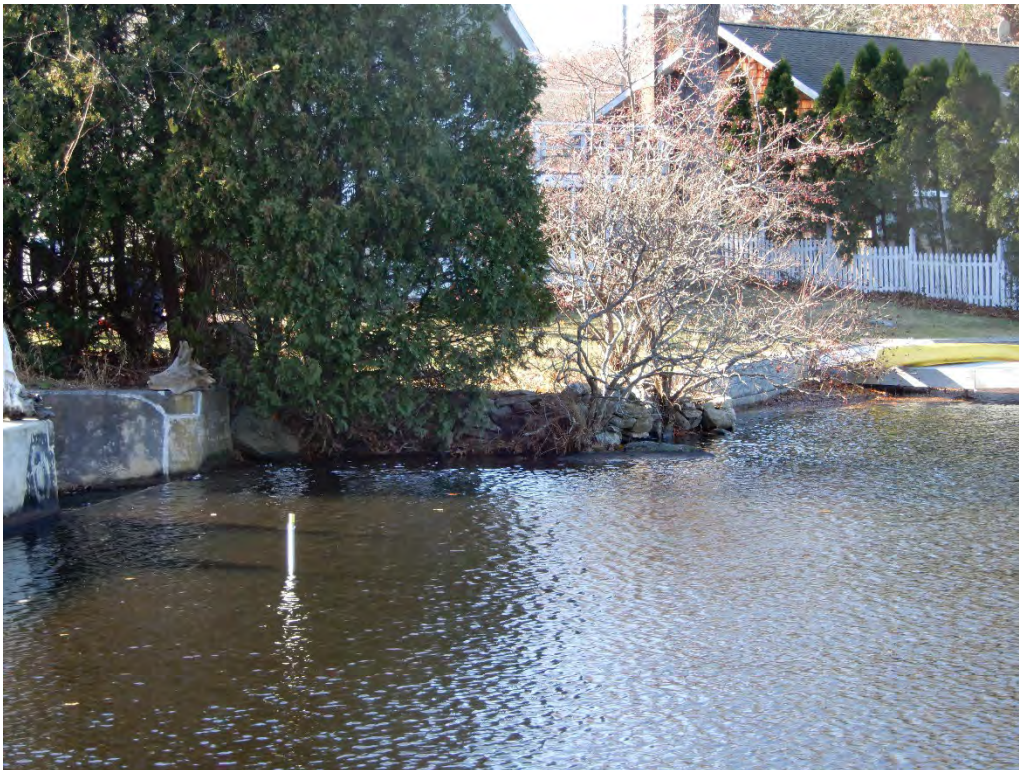
Photo 4c – Another view of the upstream side, seen from the left and concentrating on the right side of the dam near the spillway approach.

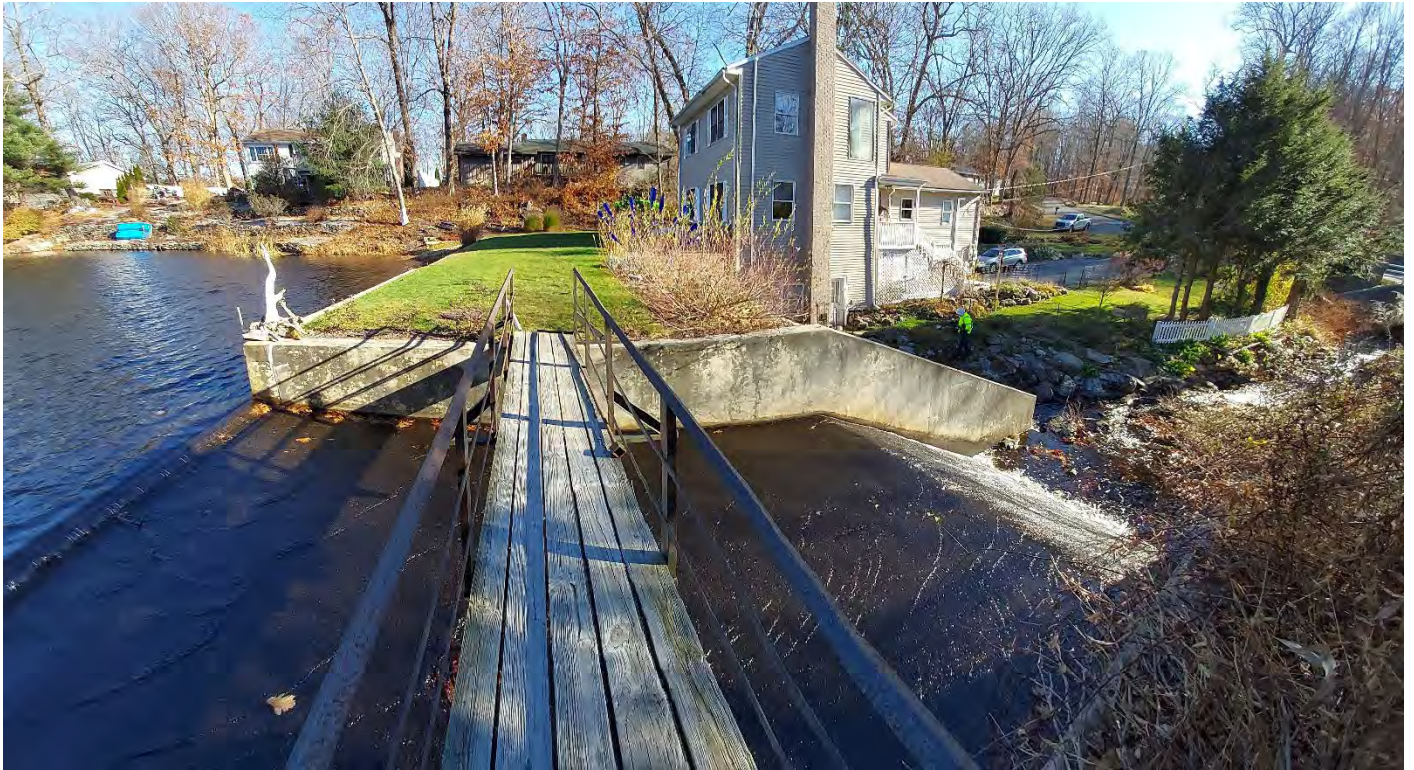
Photo 5a – The crest of both the spillway and dam as viewed from the right side abutment.

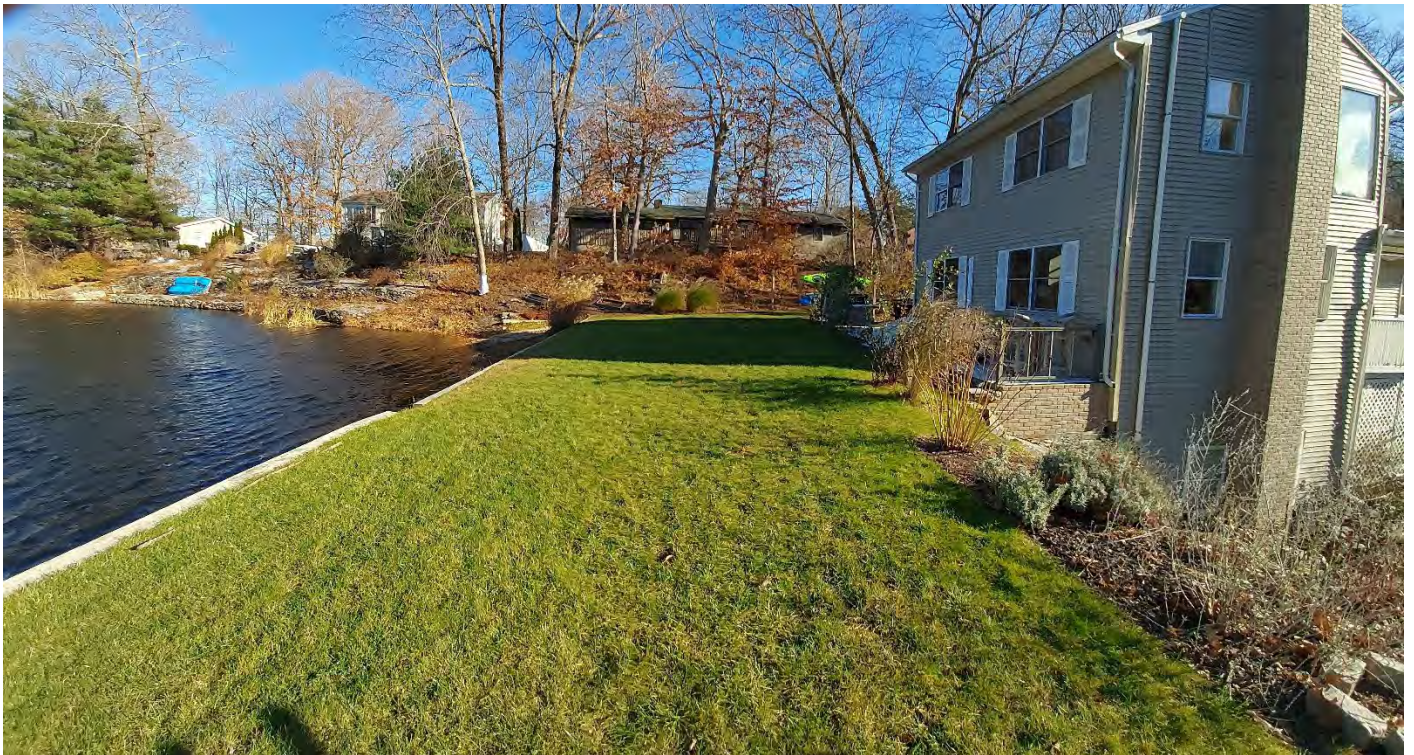
Photo 5b – Another view of the dam crest as seen from the left side of the spillway.

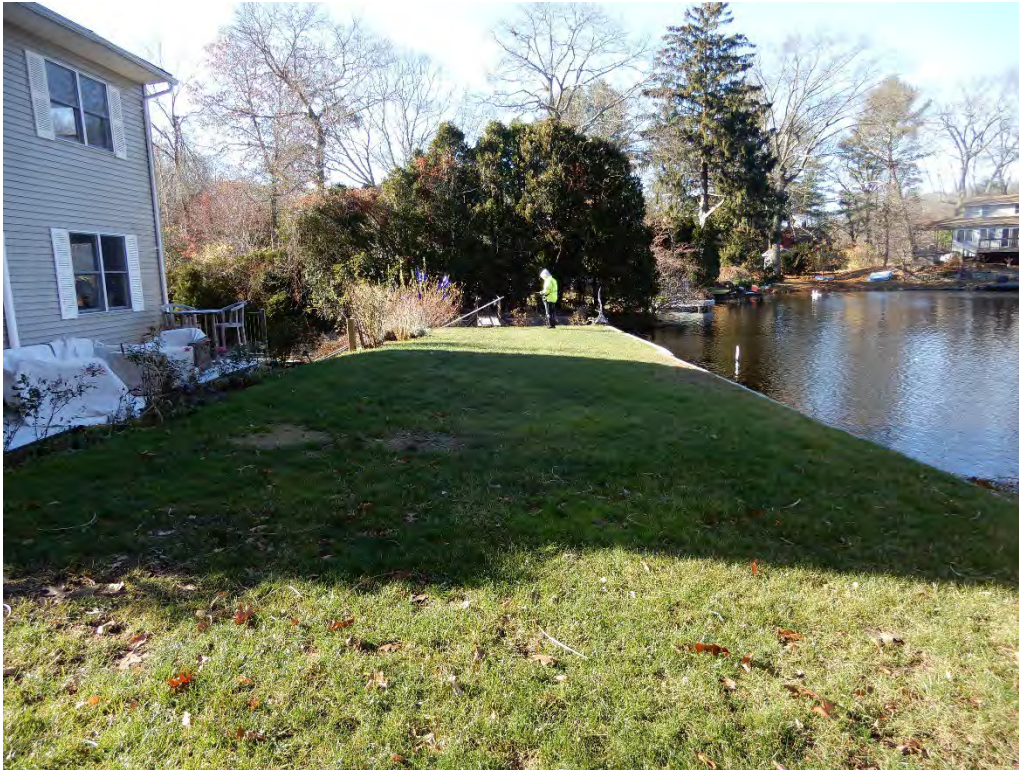
Photo 6a – The dam crest seen from the left side abutment.

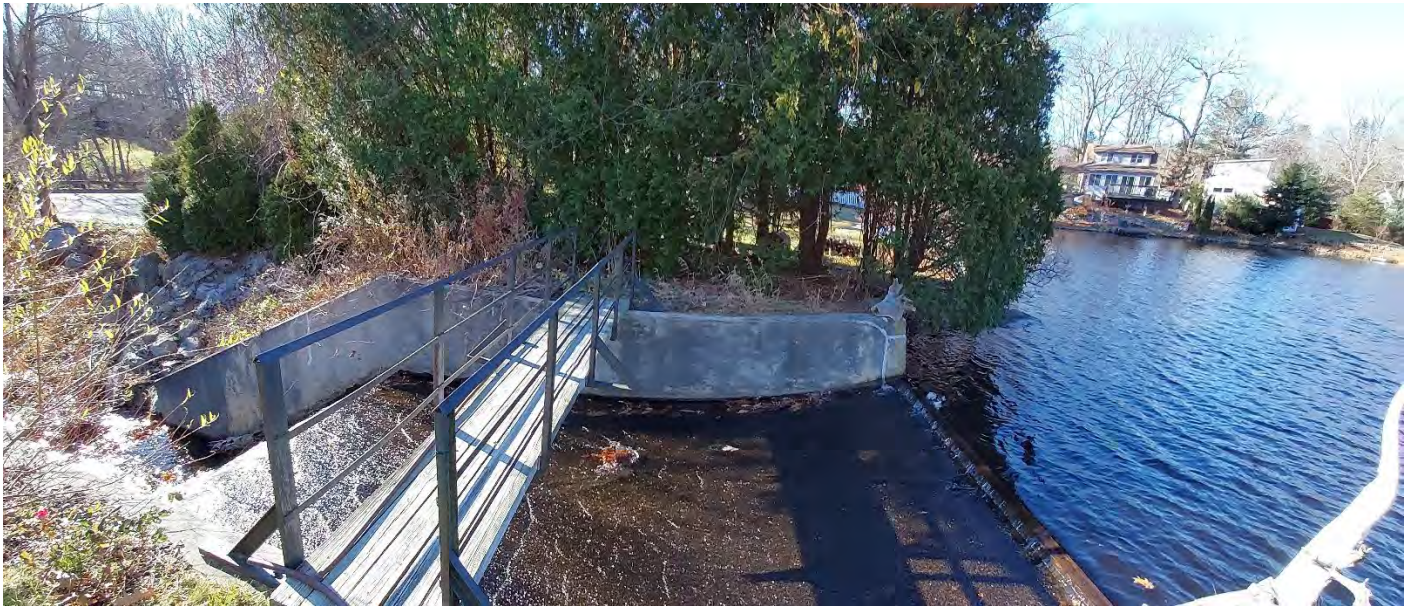
Photo 6b – A continued view of the crest area adjacent to the spillway, as seen from the perspective of the previous photo.

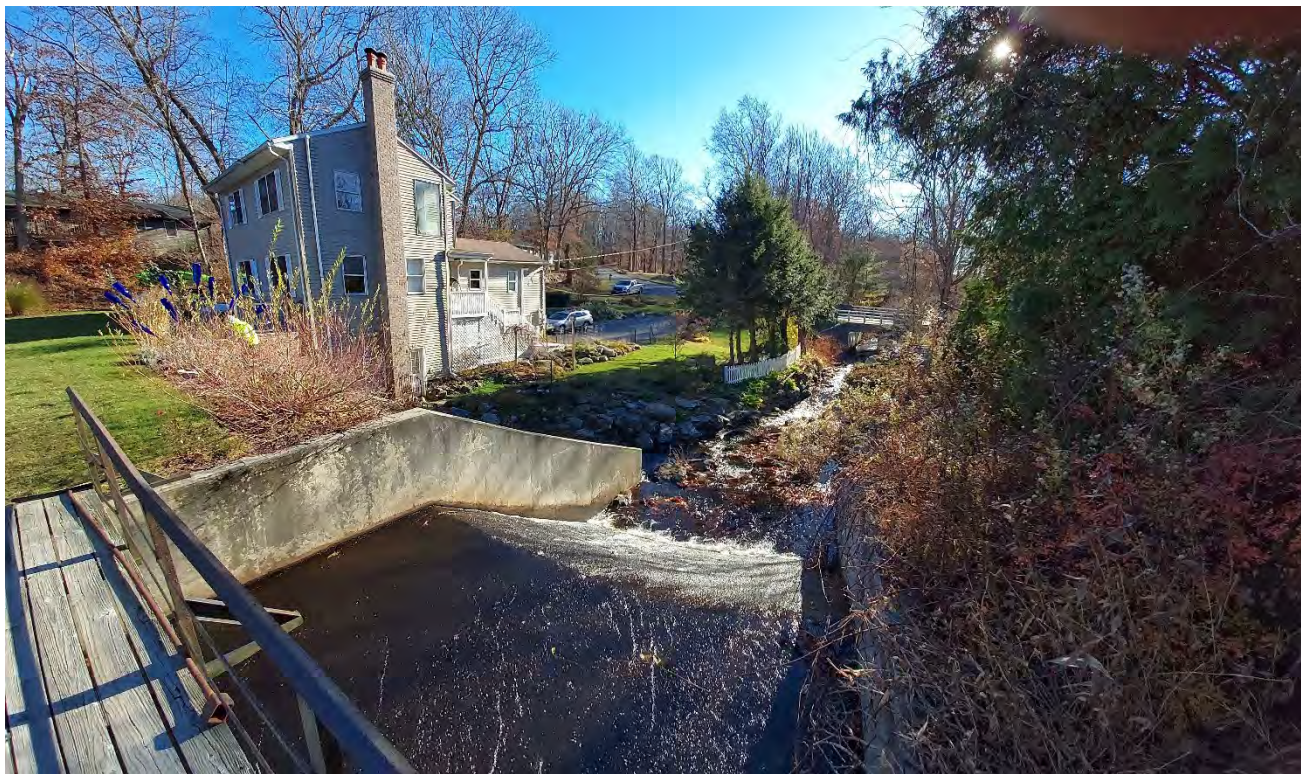
Riprap: Large riprap is present along the downstream slope left of the spillway and west (right) of the house. Its void areas are filled with concrete and the area is in good condition.

Photo 7a – The downstream face, seen from the right side abutment. Note that the house is set into the left side downstream embankment.

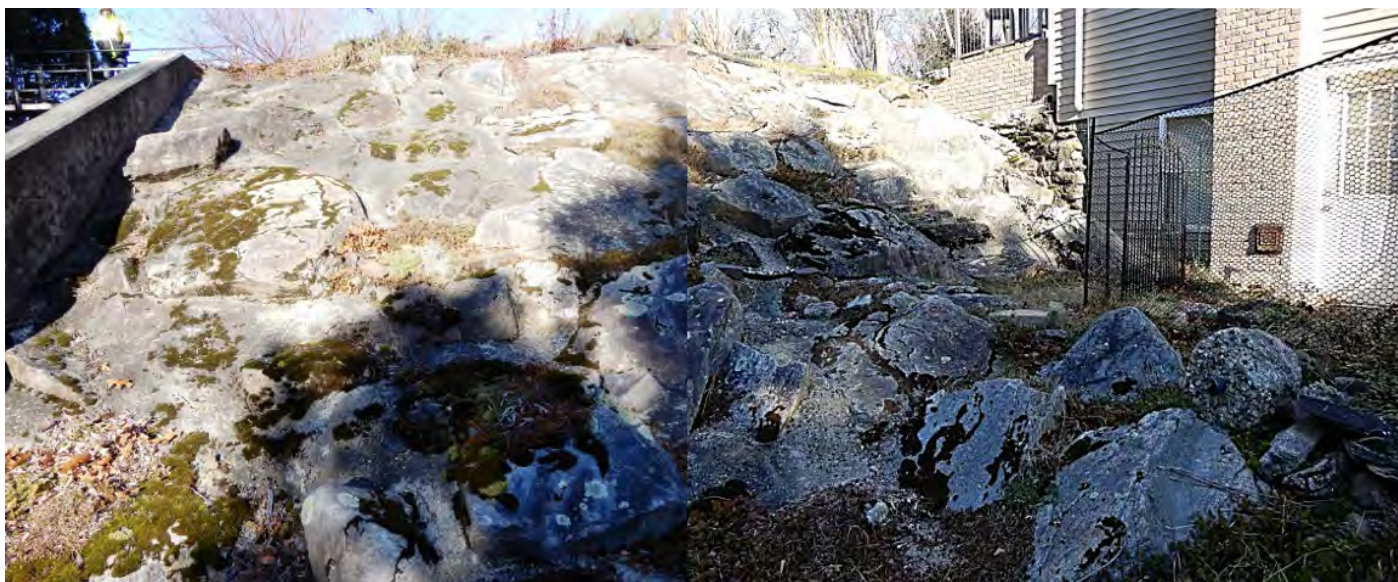
Photo 7b – The left downstream side directly adjacent to the spillway on the left and house on the right. Note that this is also a view of the older spillway location previous to the installation of the spillway on the left side of the photo, constructed in the 1993 – 1994 period.

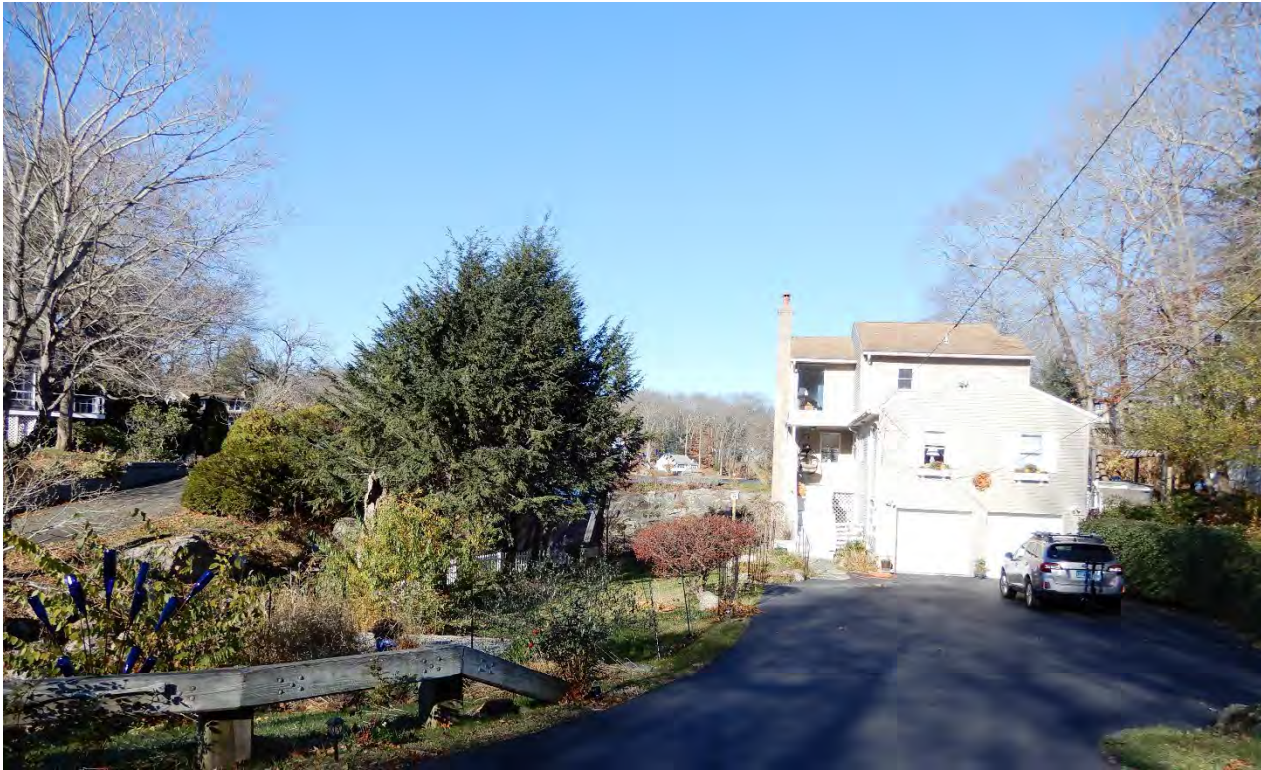
Photo 7c – A broader perspective of the left downstream side of the dam, as seen from Hidden Lake Road.

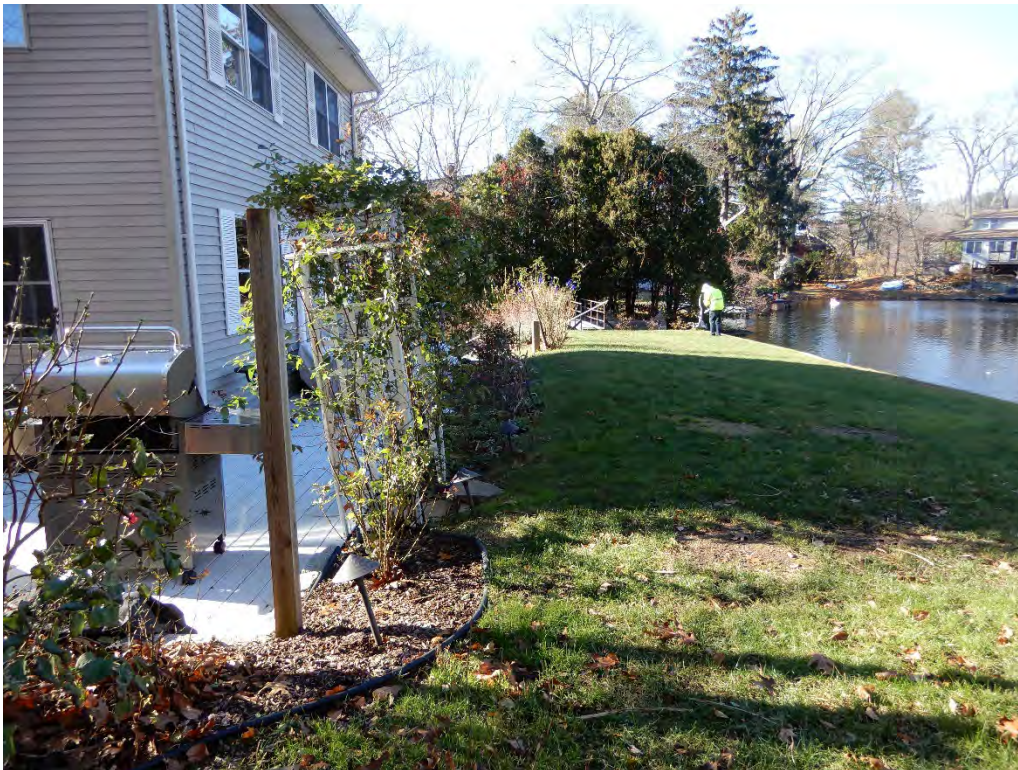
Photo 8a – The downstream face of the dam as seen from the left abutment. Note that this includes the house built into the embankment, as seen in the previous photos.

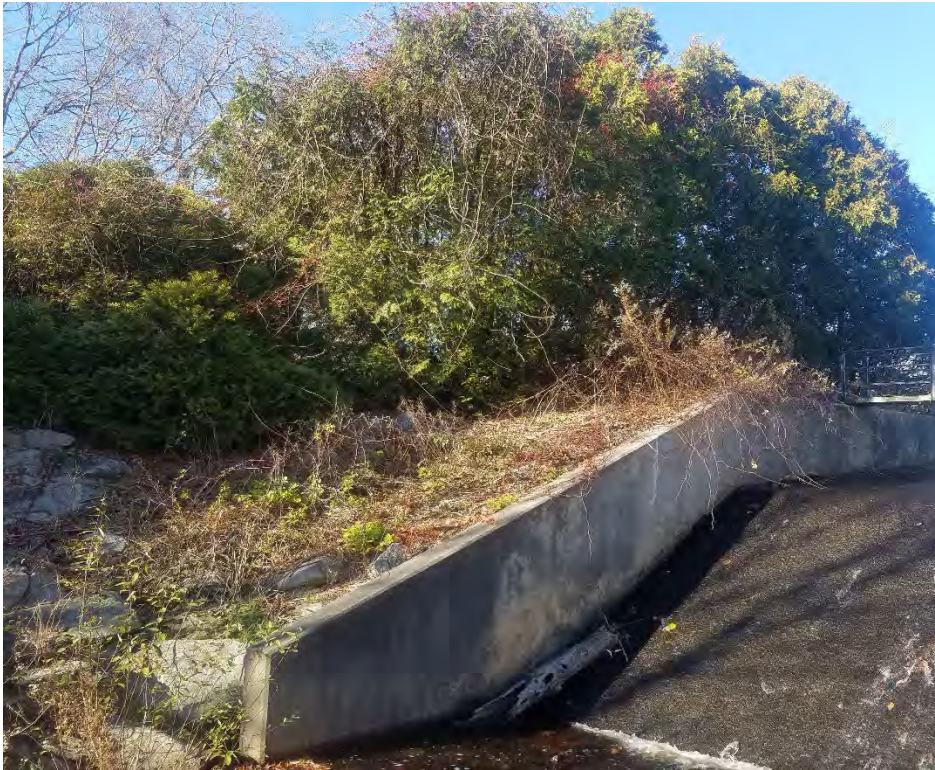
Photo 8b – A continued view of the downstream embankment showing the right side abutment from a left side perspective.

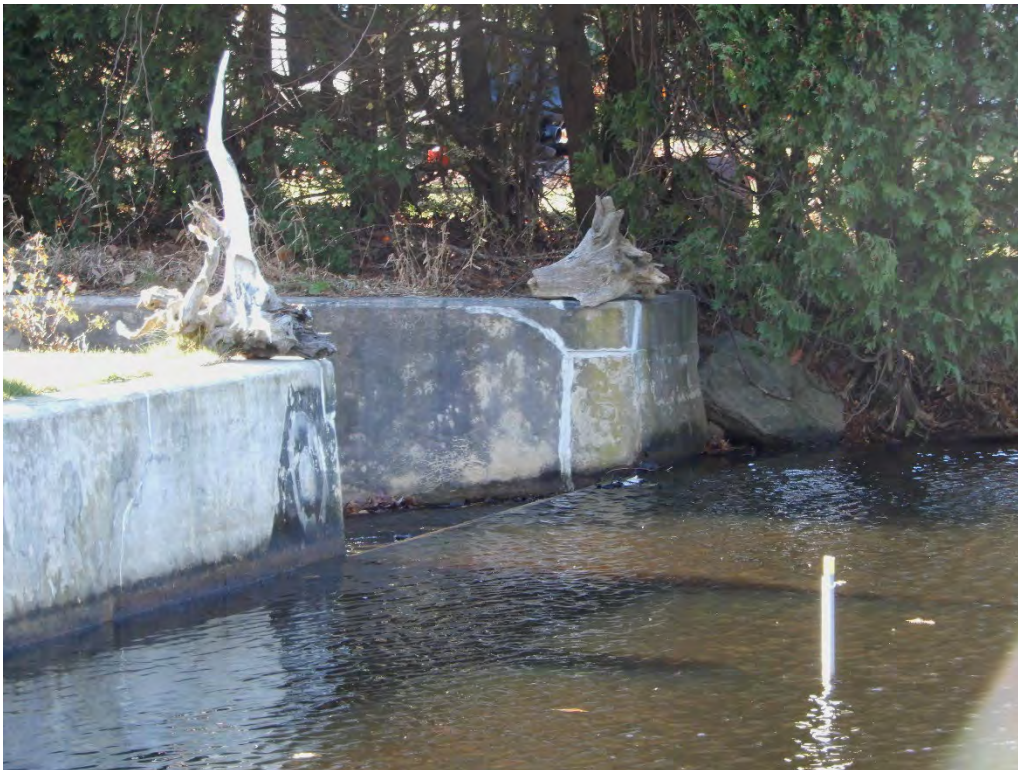
Photo 9 – The upstream approach view of the spillway.

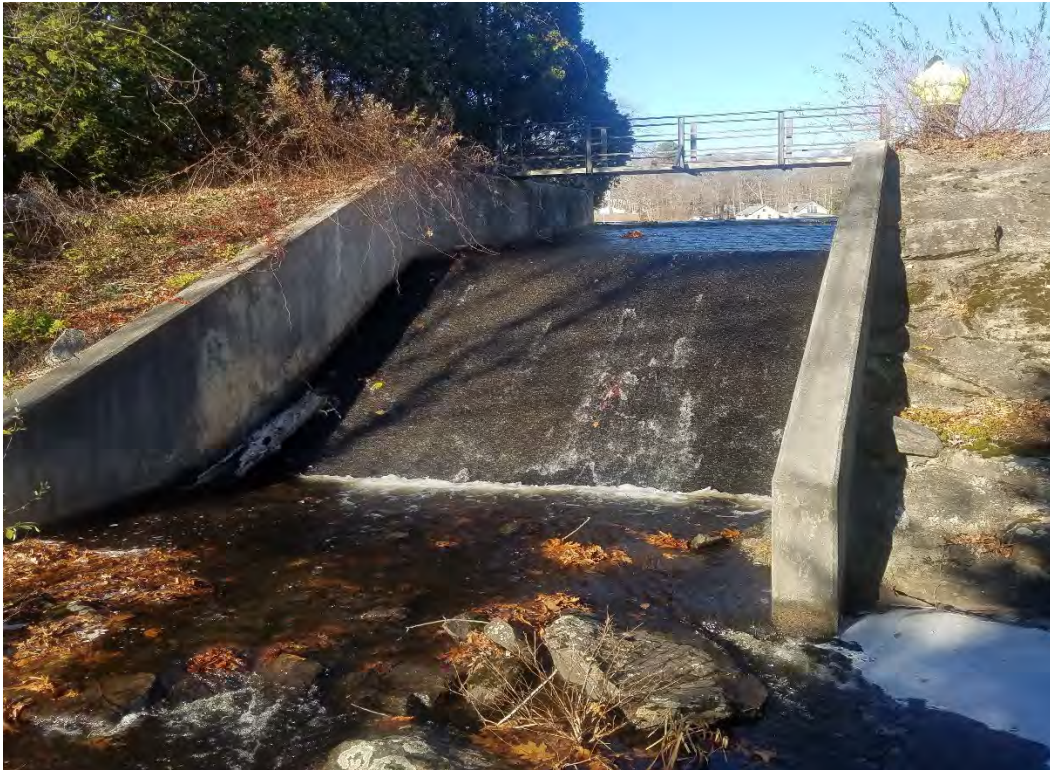
Photo 10a – The full spillway as seen from the downstream discharge channel's left side.

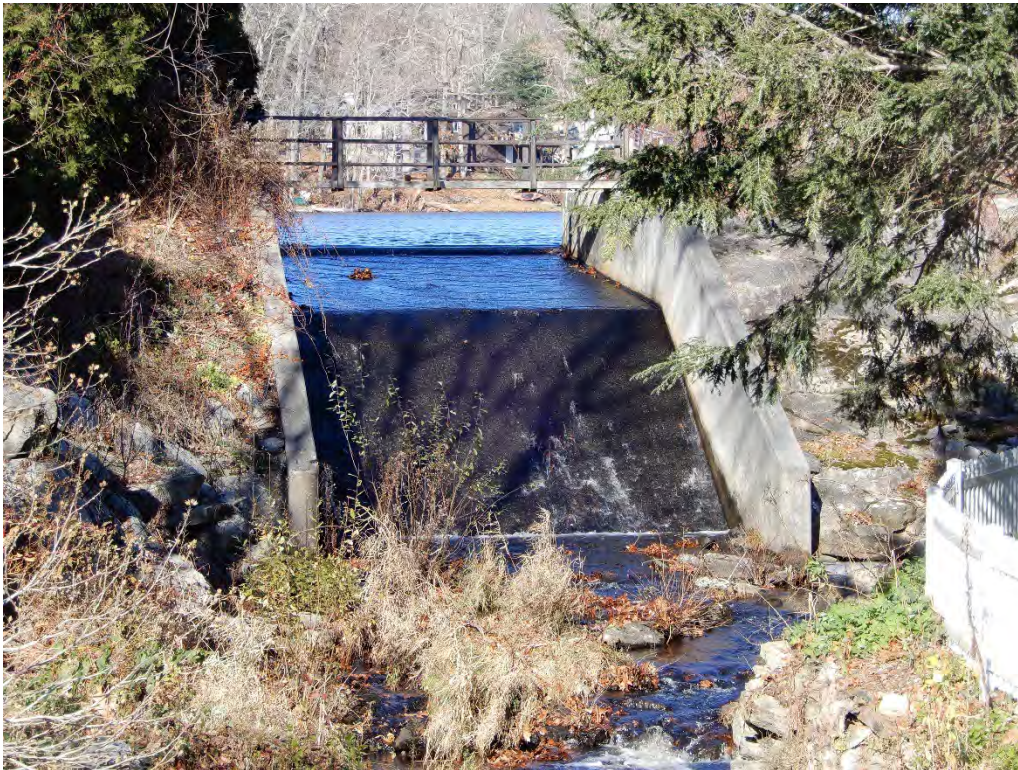
Photo 10b – Another view of the spillway from the right side of the downstream discharge channel.

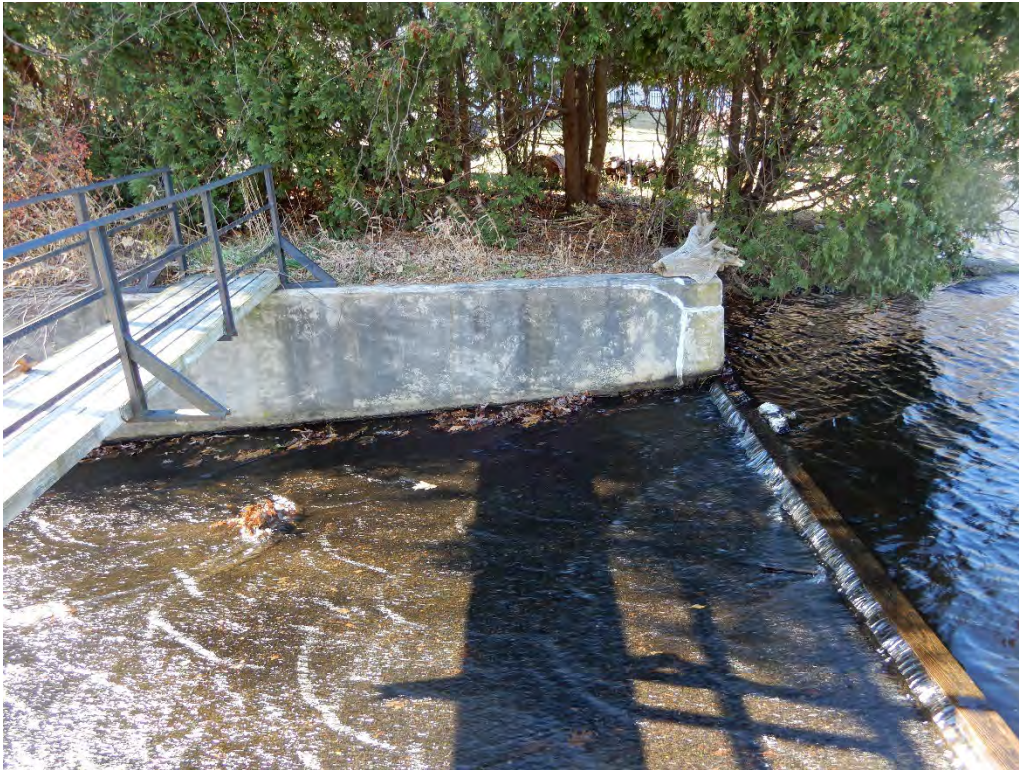
Photo 11a – The upper portion of the right side spillway training wall.

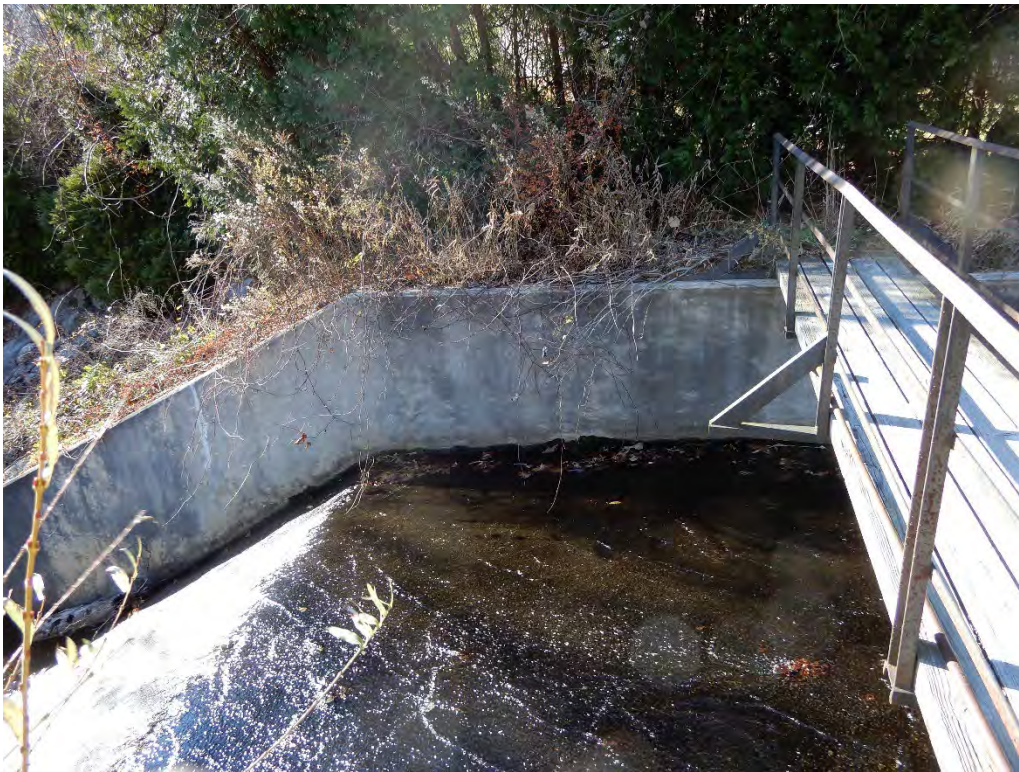
Photo 11b – The midway portion of the right side spillway training wall.

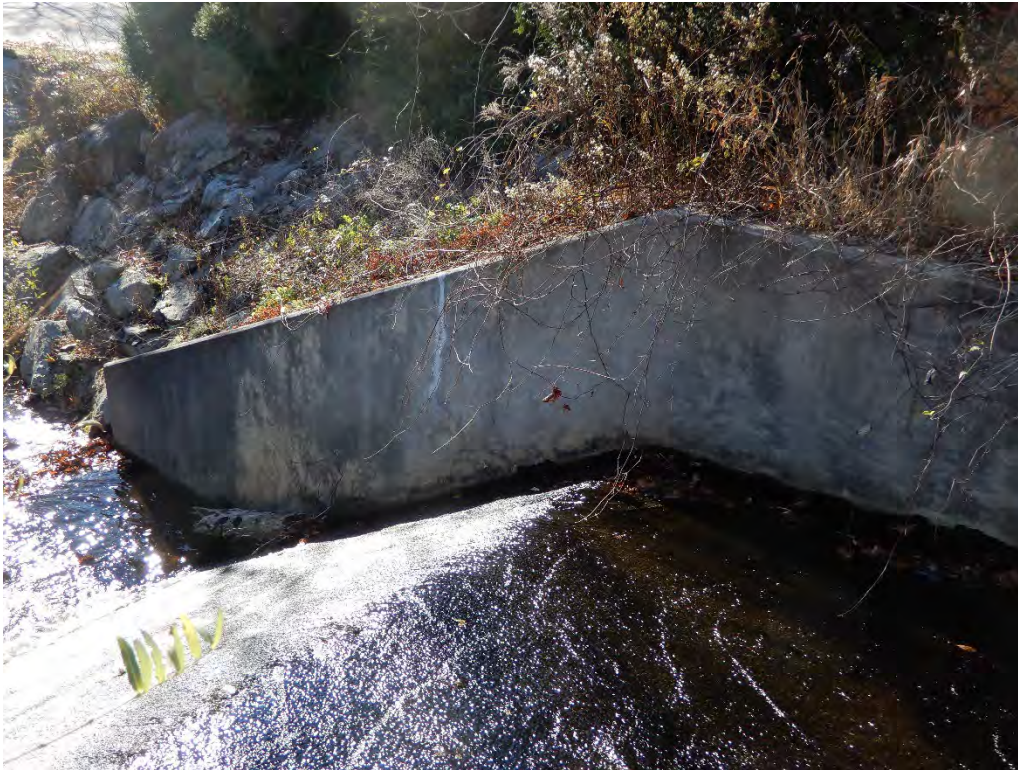
Photo 11c – The lower downstream end section of the right side spillway training wall.

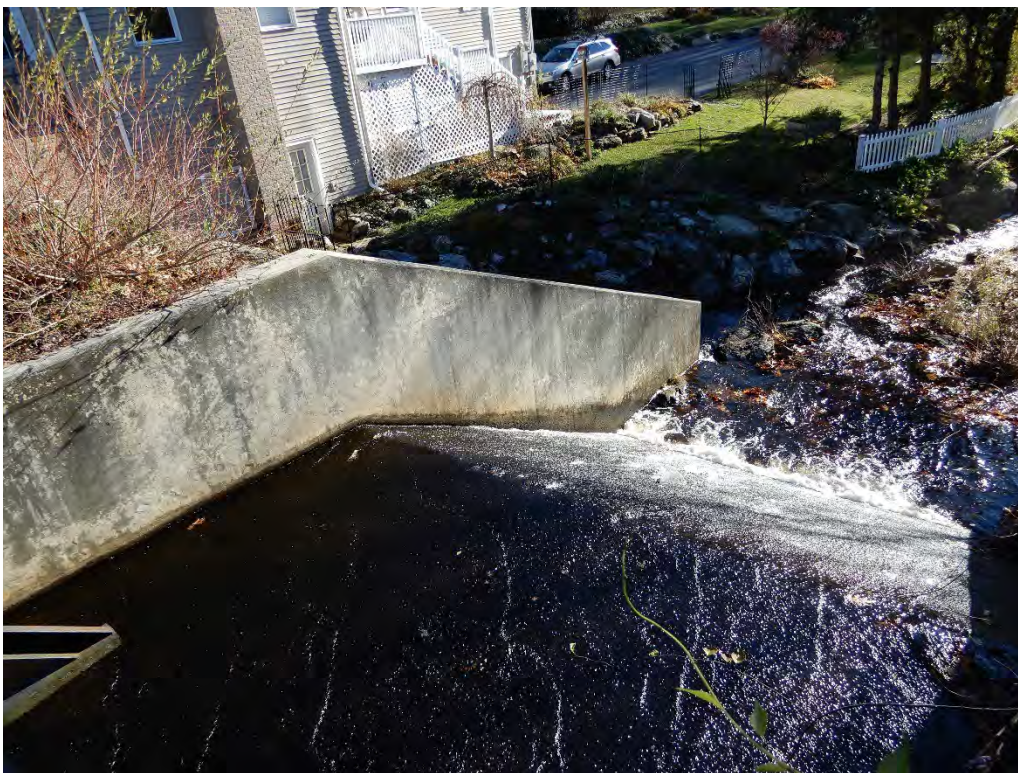
Photo 12a – The lower end section of the left side spillway training wall.

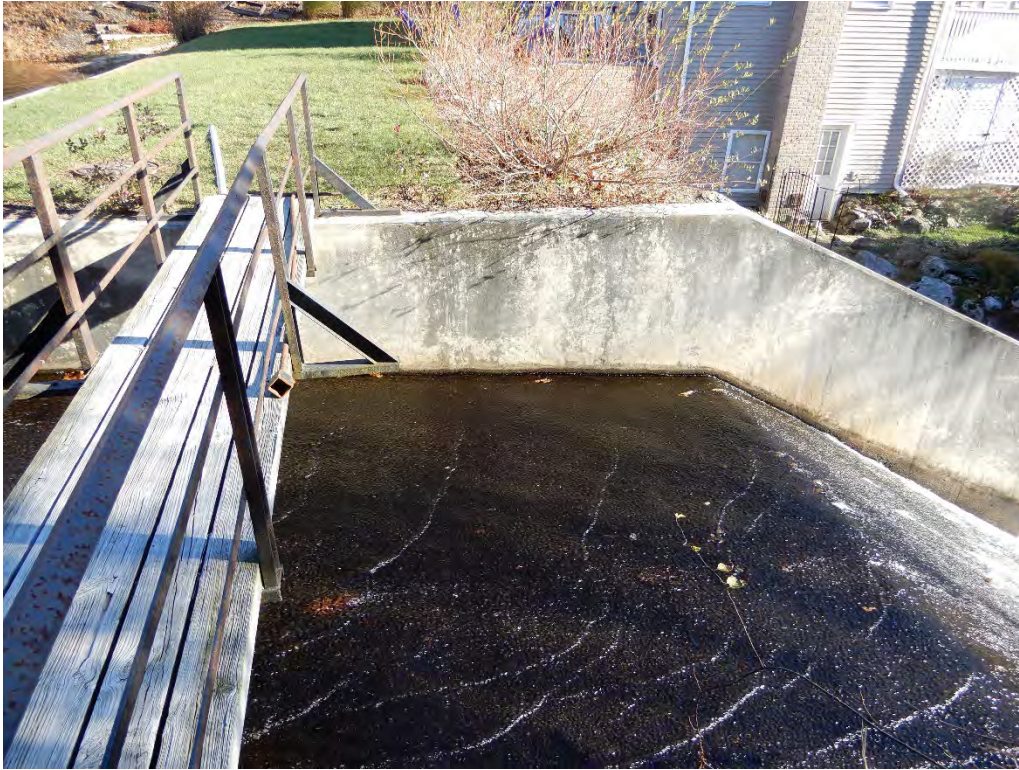
Photo 12b – The midway portion of the left side spillway training wall.

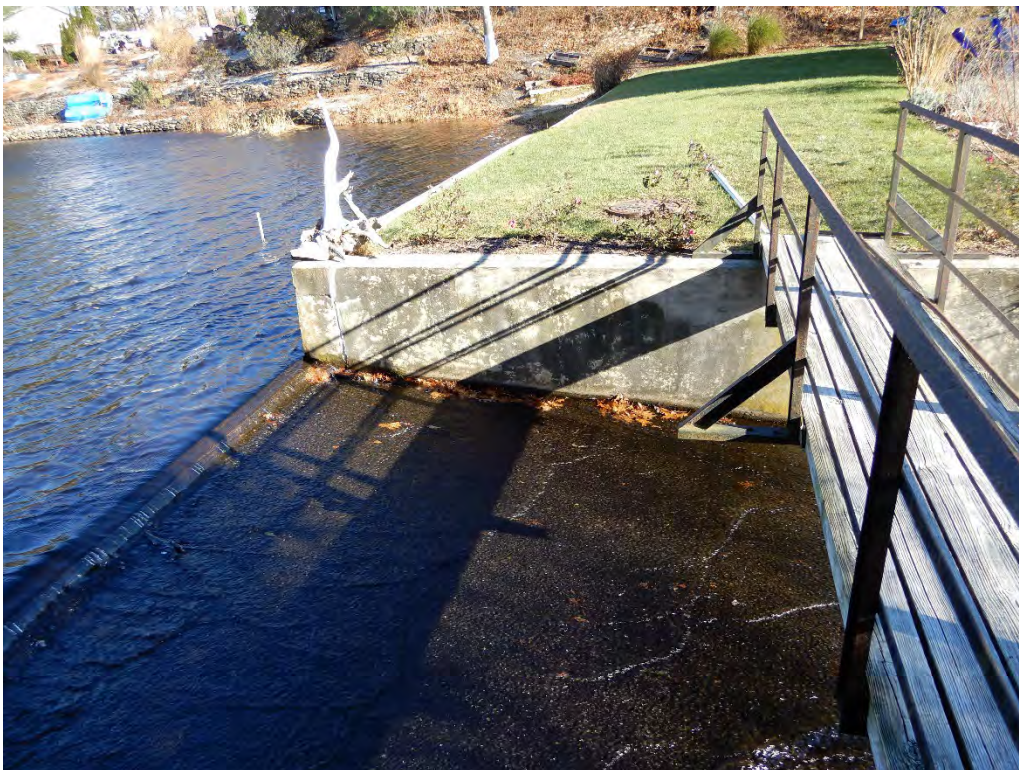
Photo 12c – The upper portion of the left side spillway training wall.

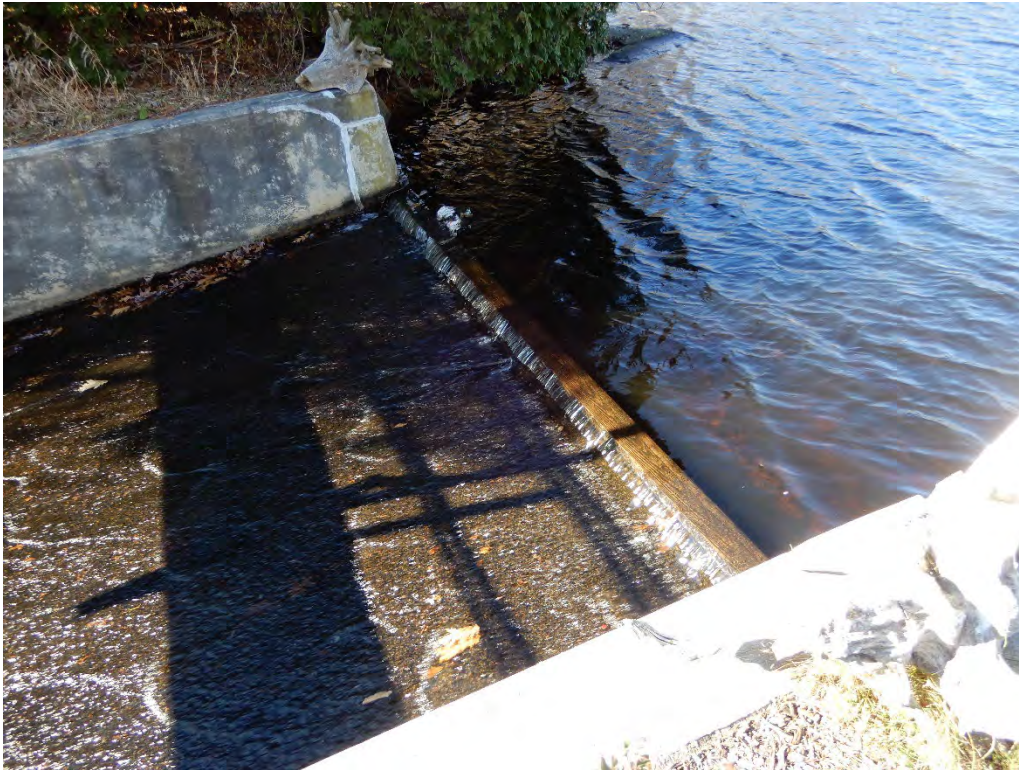
Photo 13 – An overview of the spillway weir, seen from its left side.

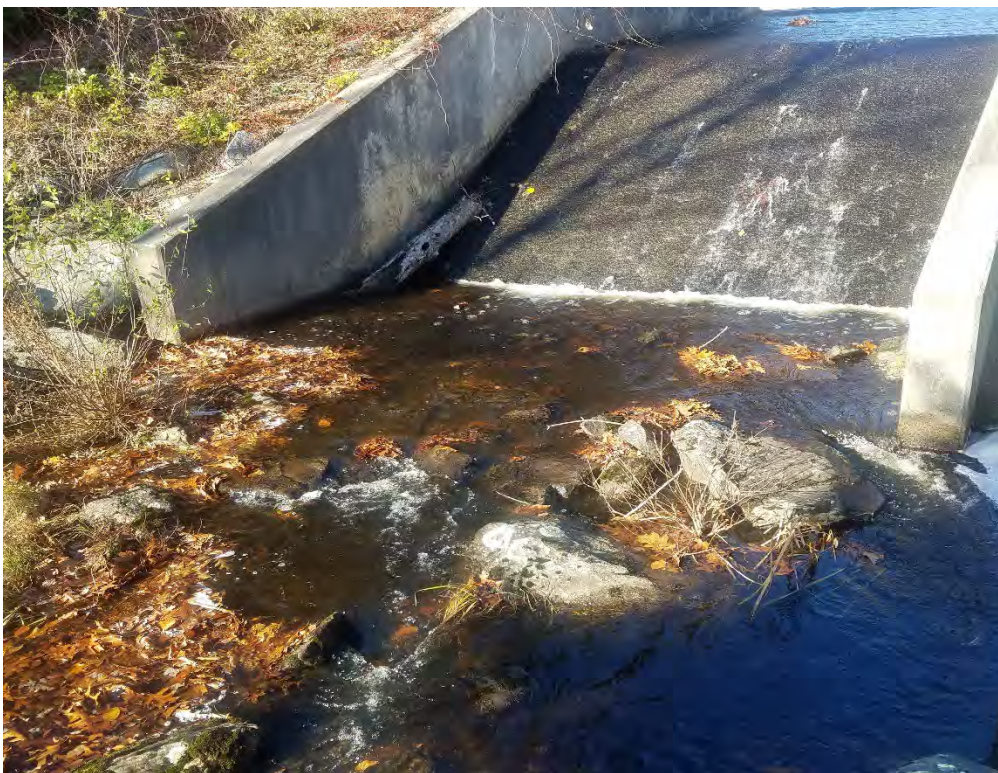
Riprap: Concrete filled riprap is present at the base of the spillway for scour protection. It is in good and stable condition.

Photo 14a – The spillway stilling basin as seen from the left downstream toe.

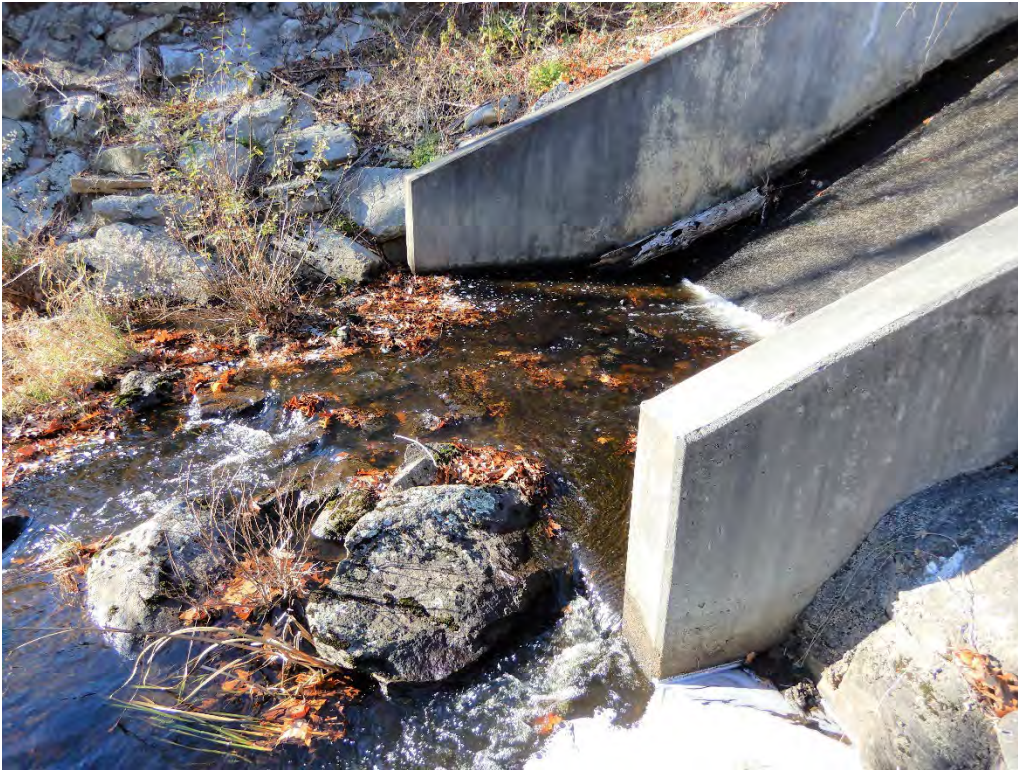
Photo 14b – Another view of the stilling basin at the downstream toe of the spillway.
