INSPECTION REPORT

HIDDEN LAKE DAM CT DEEP #06107

HIDDEN LAKE ROAD
TRIBUTARY TO POND MEADOW BROOK
HADDAM, CONNECTICUT

MAY 2022

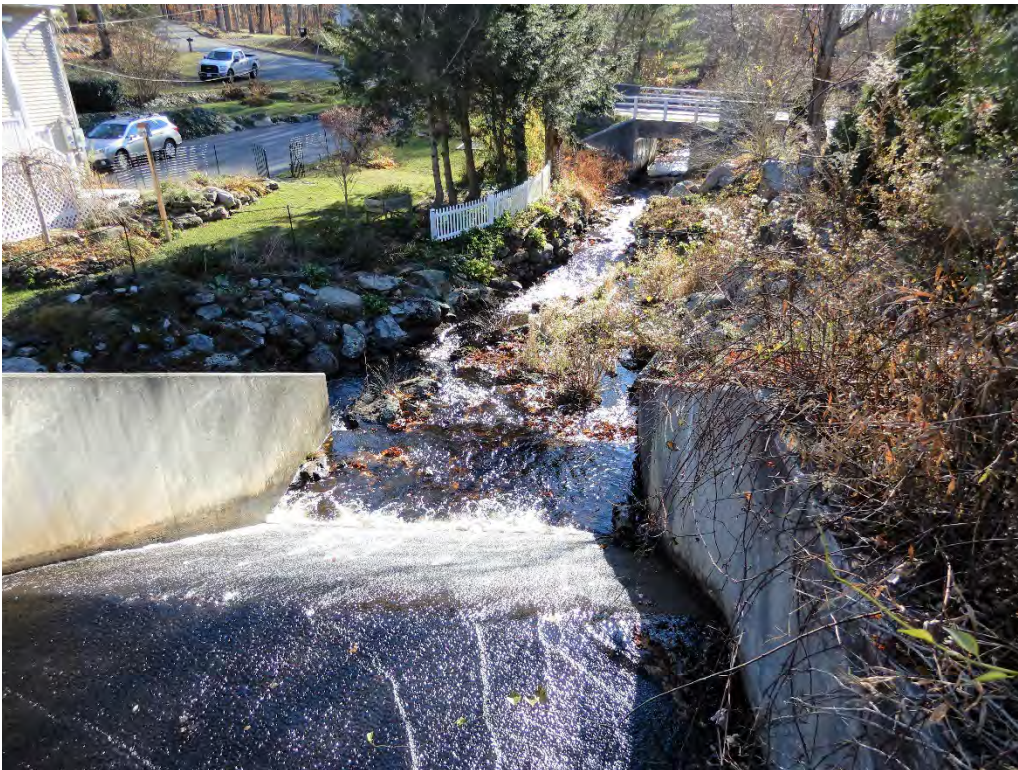
Photo 15a – The downstream channel, seen from the pedestrian bridge crossing of the spillway, looking toward the bridge crossing of Hidden Lake Road.

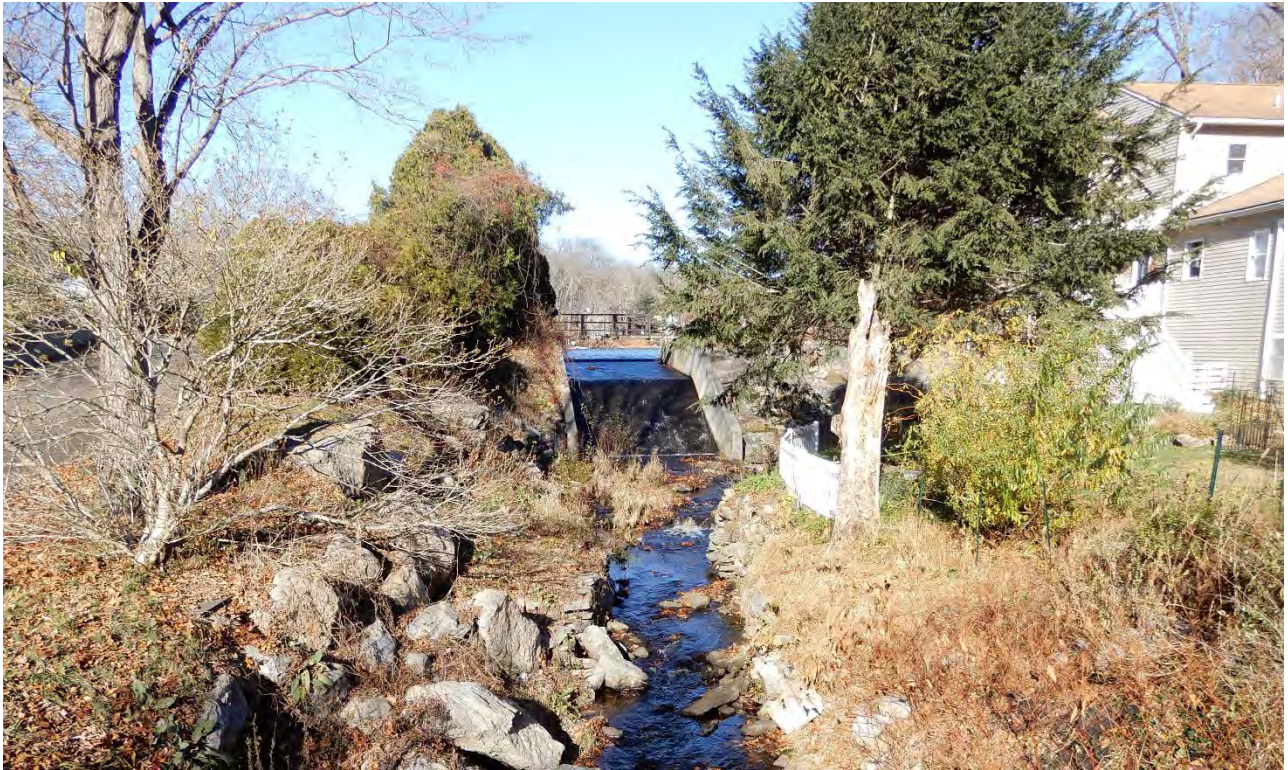
Photo 15b – Another view of the downstream channel, seen from the perspective of the bridge crossing noted in the previous photo.

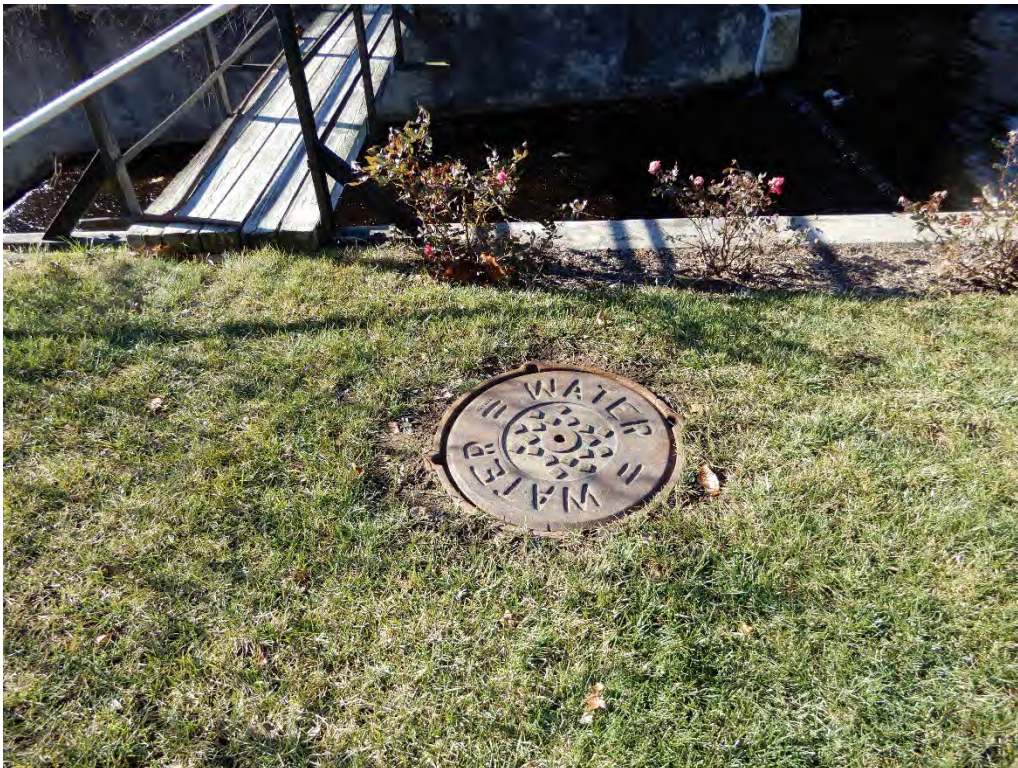
General Condition: Good on the exterior; the interior was not available for viewing on the date of inspection. The valve is reportedly used by the association on a regular basis.

Photo 16 – An exterior view of the manhole housing the gate valve and control stem for the low level outlet.

The low level outlet valve control chamber should, as noted at the time of previous inspections, be pumped out on a regular basis (once annually) and its interior checked for any deterioration or other issues that would impede routine operation of the valve. Its discharge point, adjacent to the left downstream training wall, should also be inspected during a low flow period and cleared of any obstructions that may block its outflow.

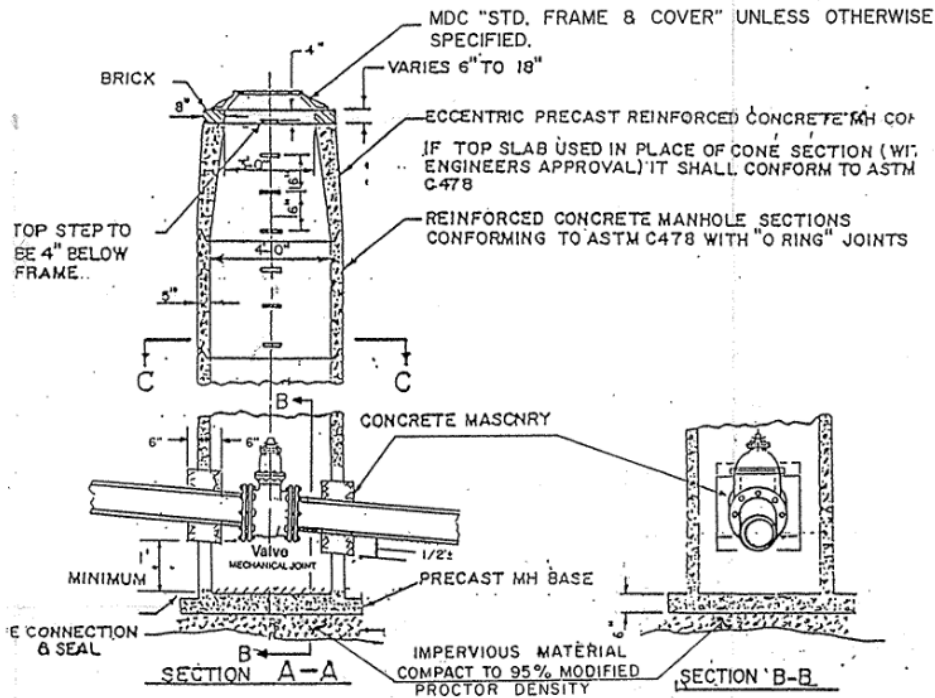
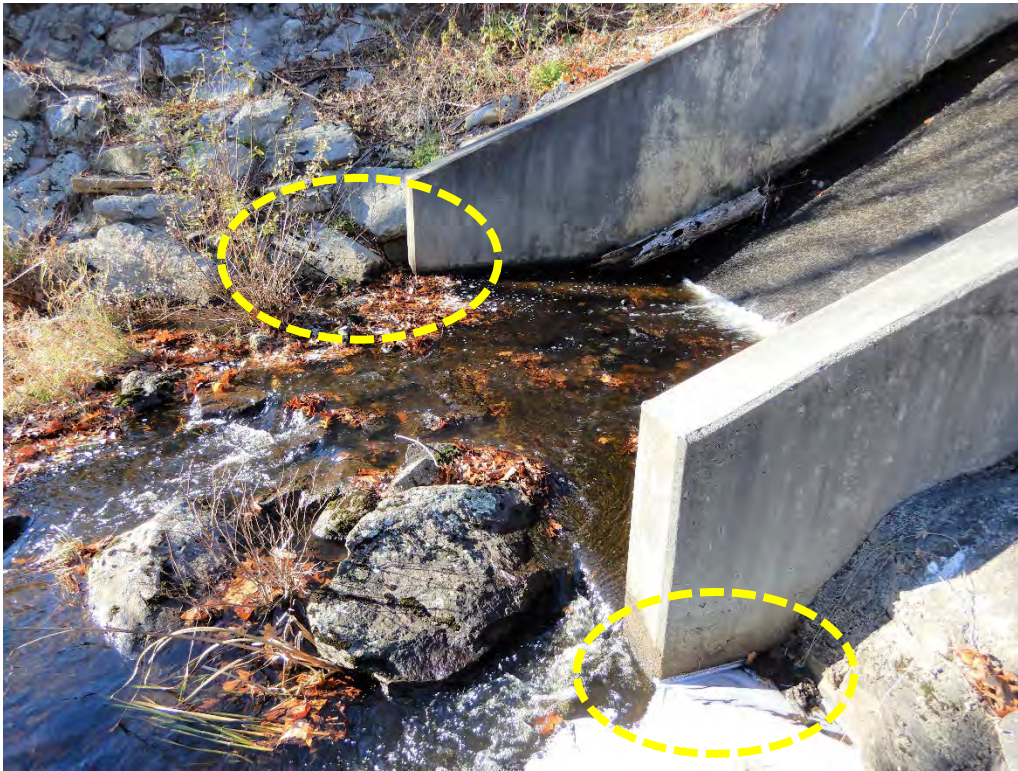
Photos 17 & 18 – Overviews of the valve chamber interior and valve control mechanism were not available at the time of inspection. The following sketch, taken from original installation drawings prepared by Luchs & Beckerman, depicts the interior gate valve and AWWA nut on top to accommodate a T-wrench for valve operation. The interior chamber is, reportedly, normally filled with water; the valve is, however, operable, and used on an annual basis.

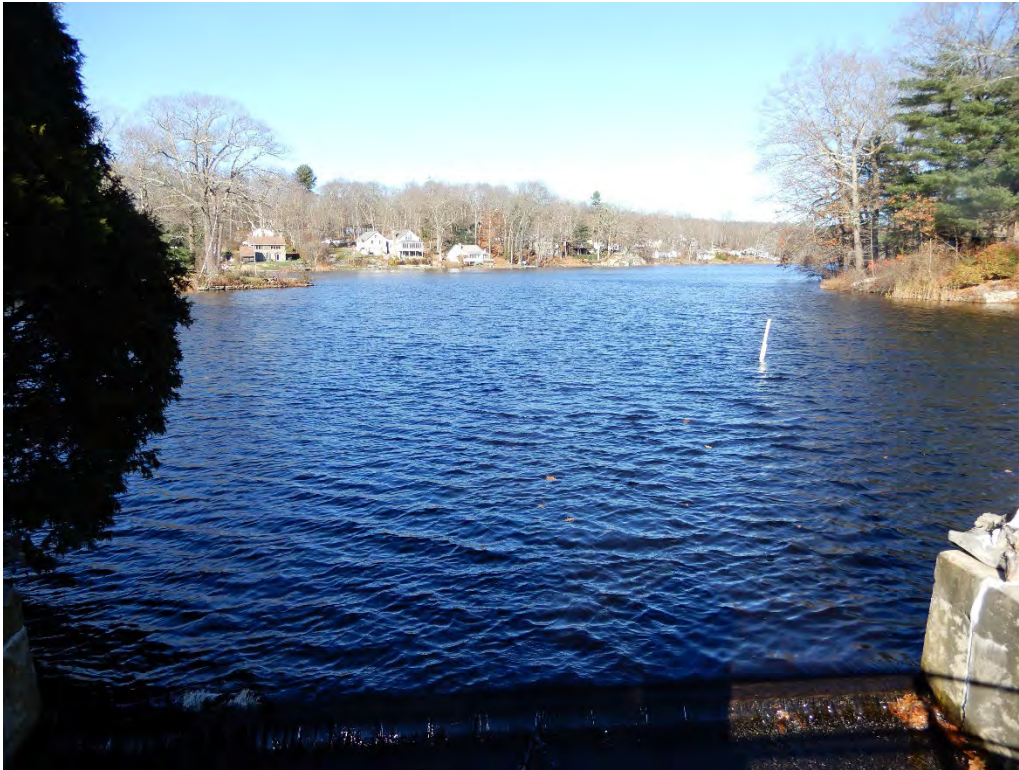
Photo 20a – An overview of the lake, taken from the spillway pedestrian bridge crossing.

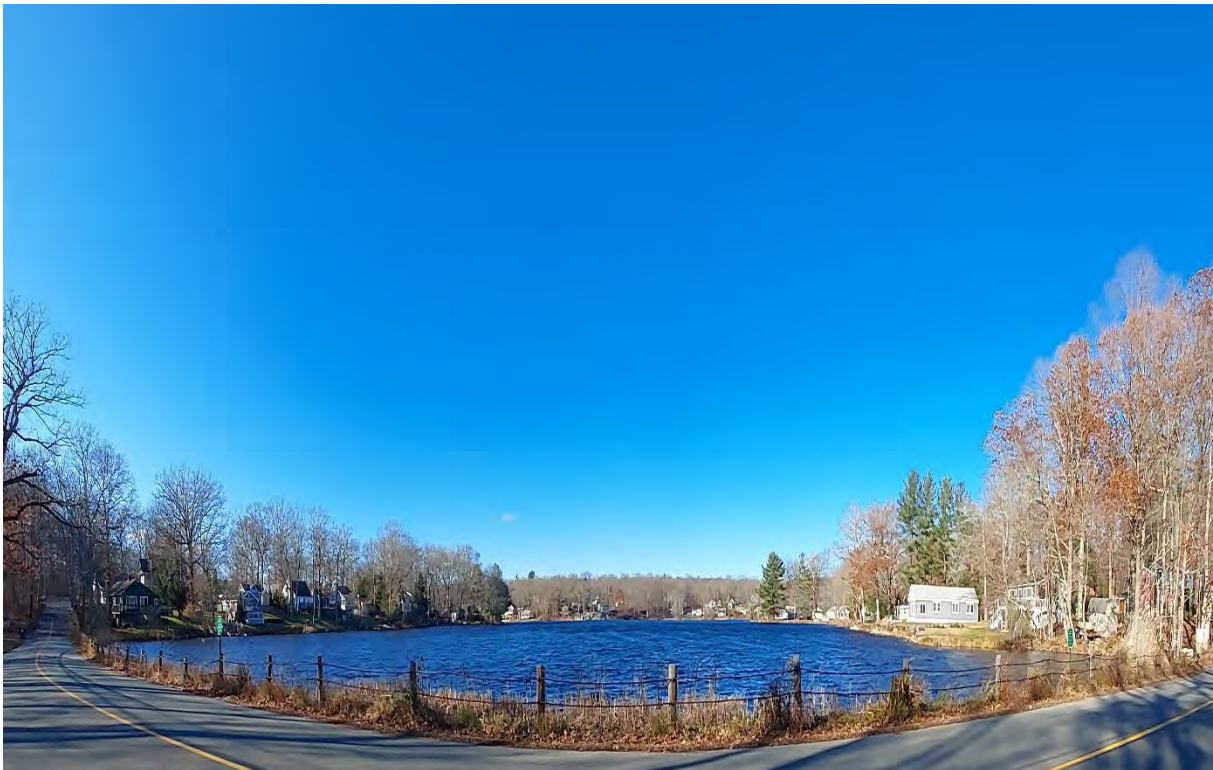
Photo 20b – An upstream view of the lake as seen from the auxiliary spillway, a road crossing approximately 1,300 feet east southeast of the dam.

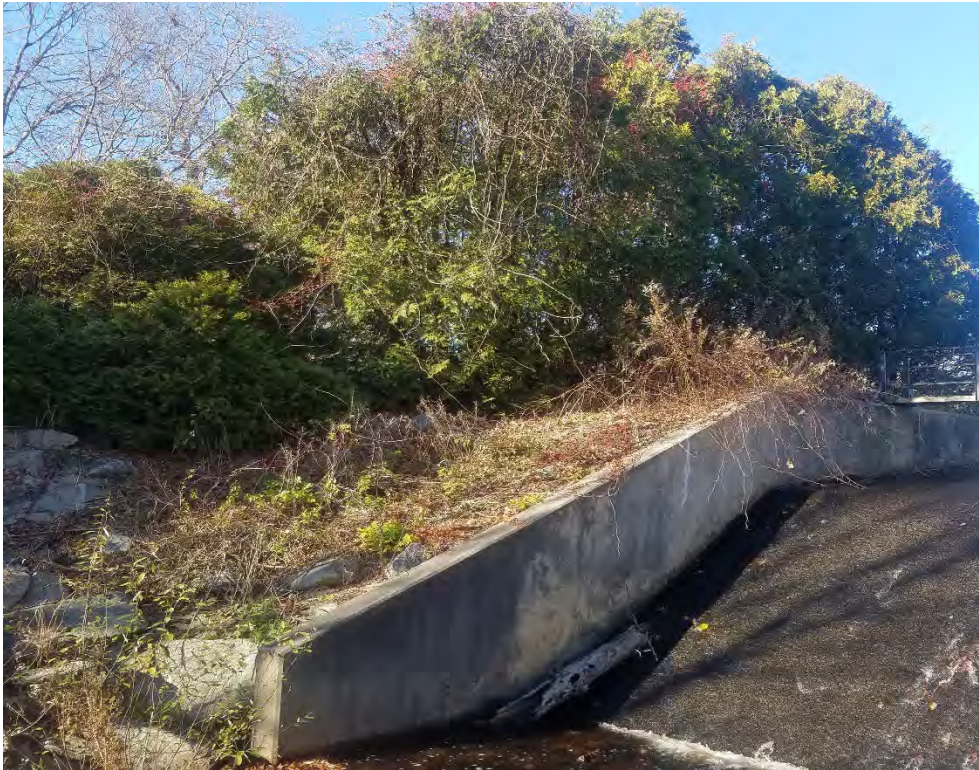
Vegetative Cover: There is a well maintained grass cover on the crest of the left embankment. The right embankment does have trees and brush just right of the spillway discharge apron.

Photo 21a – Tree and brush cover along the right side abutment of the dam. See discussion under Recommendations for removal directives.

In areas of the downstream channel beyond the 25-limit, we recommend that the density of trees and brush be maintained at a low level, as this will maintain efficient hydraulic flow and minimize potential impact on downstream areas in the event of a severe storm situation.

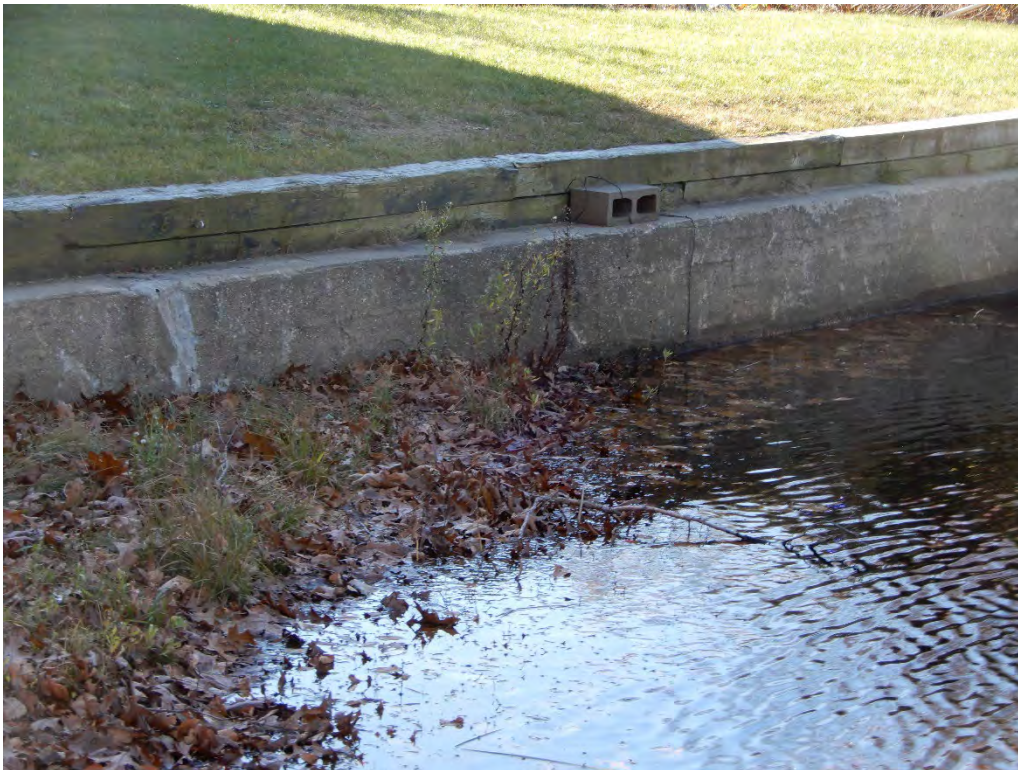
Cracks: One small crack or joint area is to be monitored at the left upstream corner of the spillway (see photos).

Photo 21b – An upstream area of the wall face along the left embankment where minor surficial cracking and joints were noted. Regular or routine monitoring is recommended in these areas.

2. **Concrete Structures** – Only minor cracking was noted along concrete surfaces and, in general, concrete was in good condition. We recommend continued and routine monitoring, however, as further recommended below. It is also recommended that joint fillers and older cracks that have been previously repaired be checked from time to time and repaired again as required, and that any significant issues be brought to the attention of an engineer.

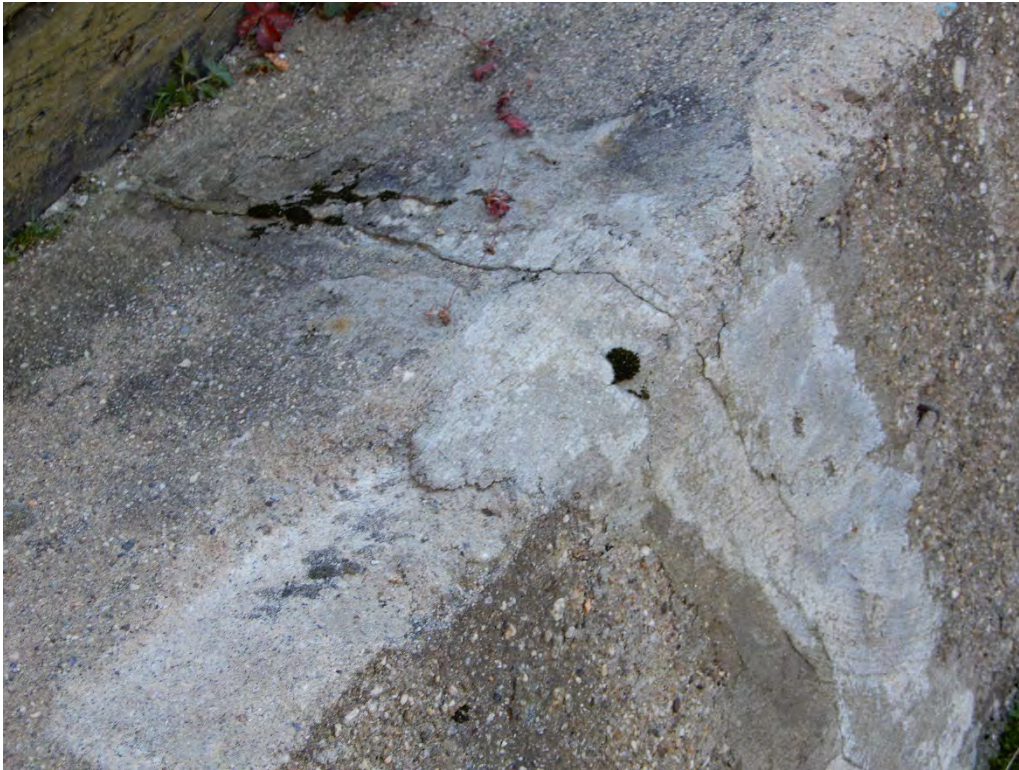
Photo 21c – A closeup of the area shown in the previous photo with an example of the minor cracking patterns developing in a previously patched area.

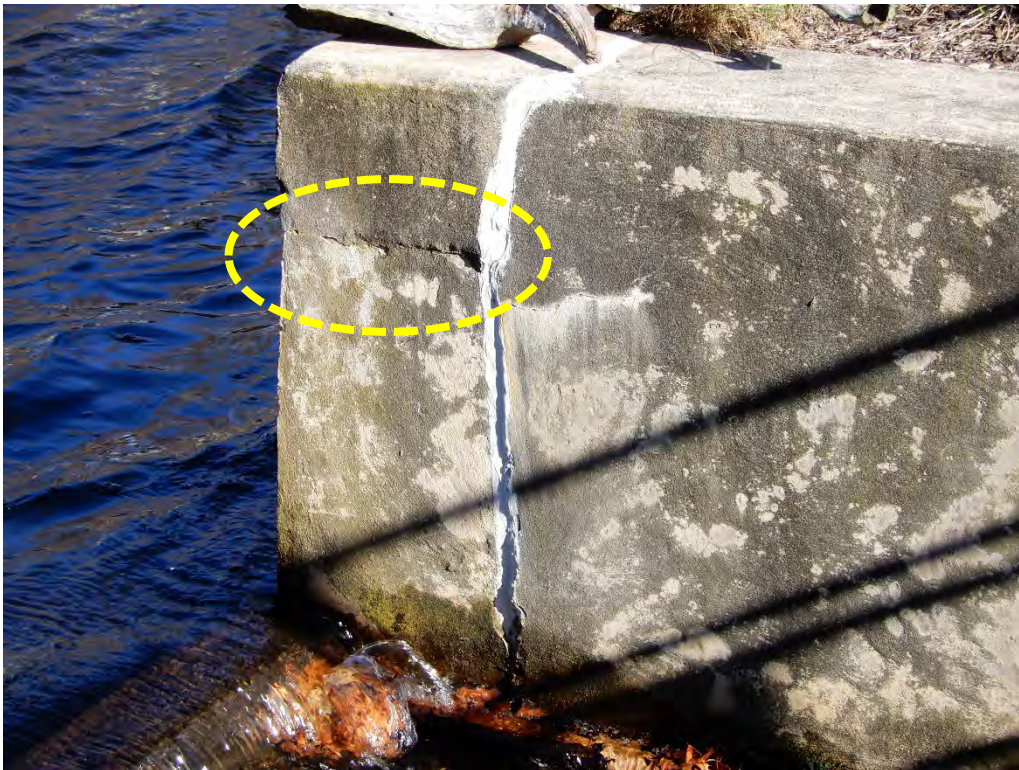
Photo 21d – A horizontal crack / joint area that needs to be monitored, adjacent to a previously sealed crack.

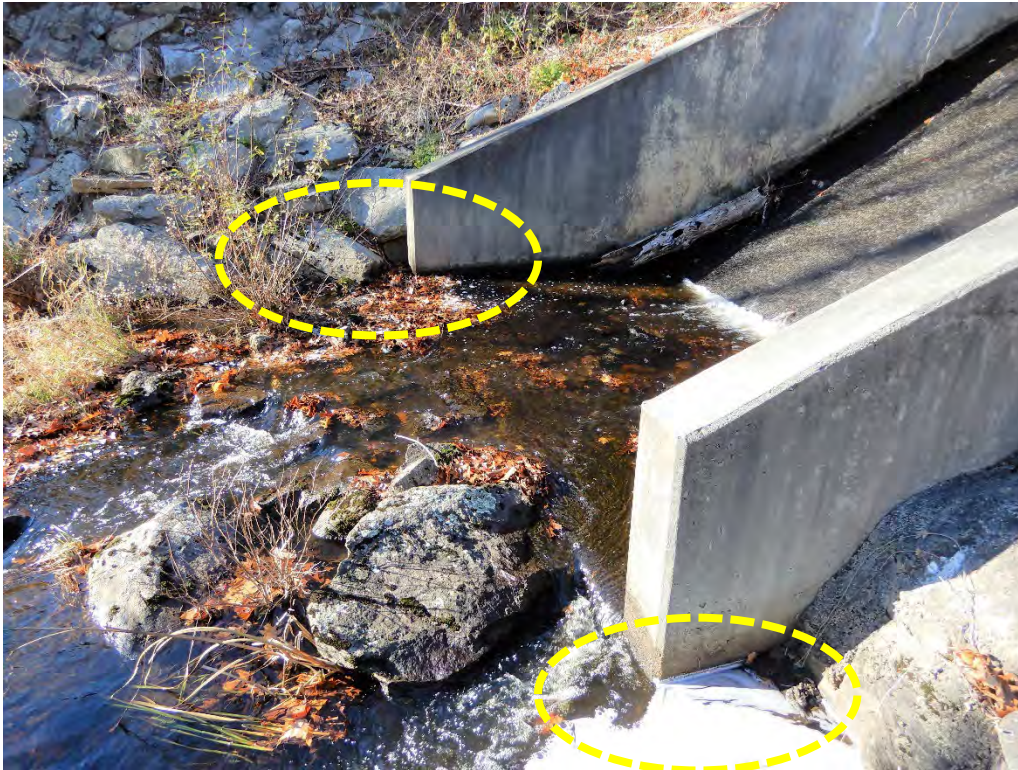
Photo 21e – Two discharge points that need to be kept clear and monitored on a regular basis. See also discussion under Recommendations.

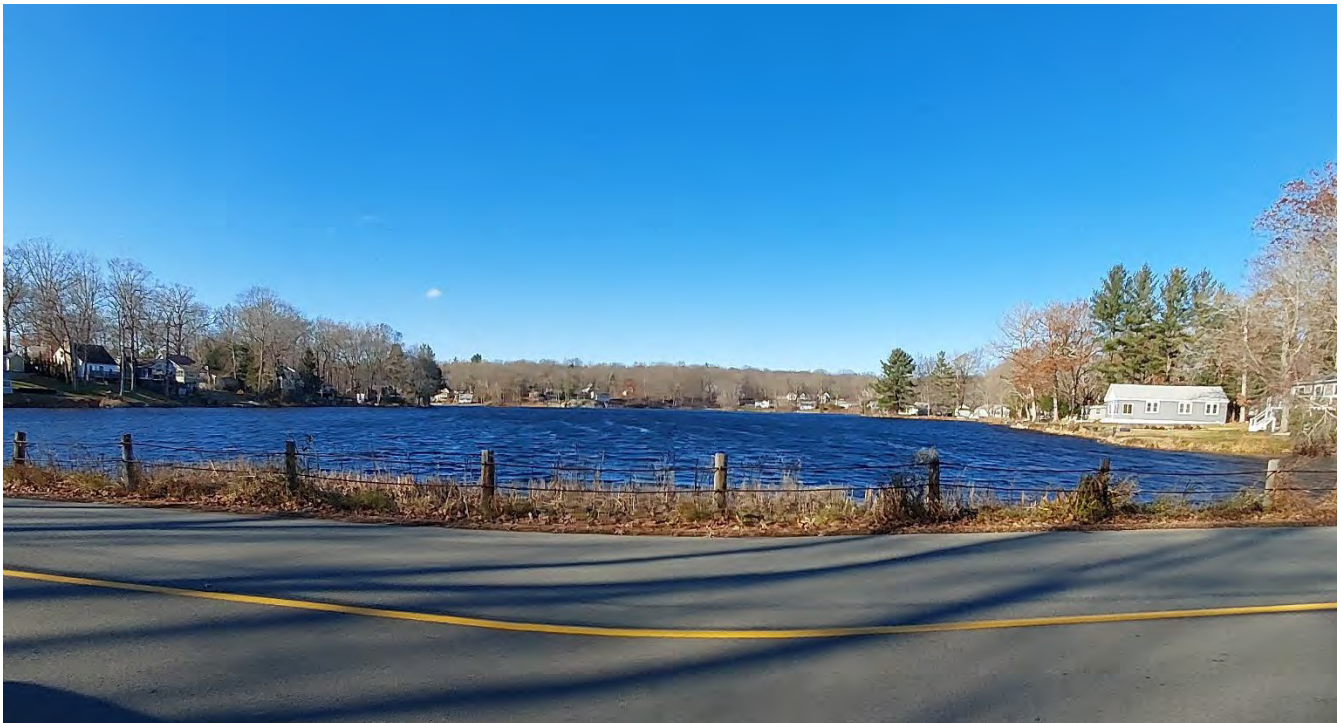
Photo 21f – An example of the current conditions of low vegetation along the shoreline of the auxiliary spillway, which should be maintained on a routine basis.

4. **Auxiliary Spillway / Hidden Lake Road** – The overflow area along the road section approximately 1,300 ft. east of the dam site was in overall good condition, including its road surface and the controlled vegetative growth along the shoreline. We recommend continued and frequent maintenance to keep the cover as low as possible to maintain clear and efficient hydraulic conditions for overflow in the event of a severe situation. A low and even cover will minimize the depth of flooding and overflow along the road surface.
