INSPECTION REPORT

HIDDEN LAKE DAM CT DEEP #06107

HIDDEN LAKE ROAD
TRIBUTARY TO POND MEADOW BROOK
HADDAM, CONNECTICUT

MAY 2022

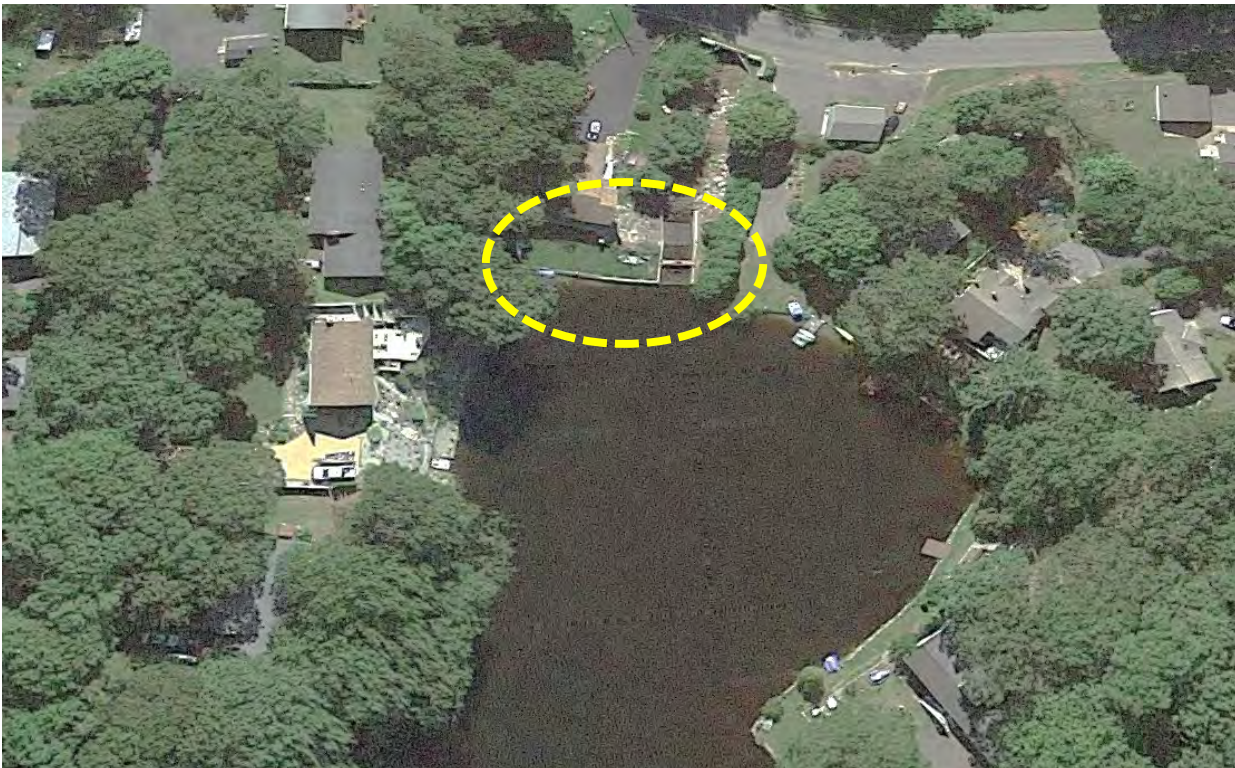
Photo 1b – Another overview from an upstream perspective, with the dam and spillway outlined in the center of the photo. [Source: Google Maps]

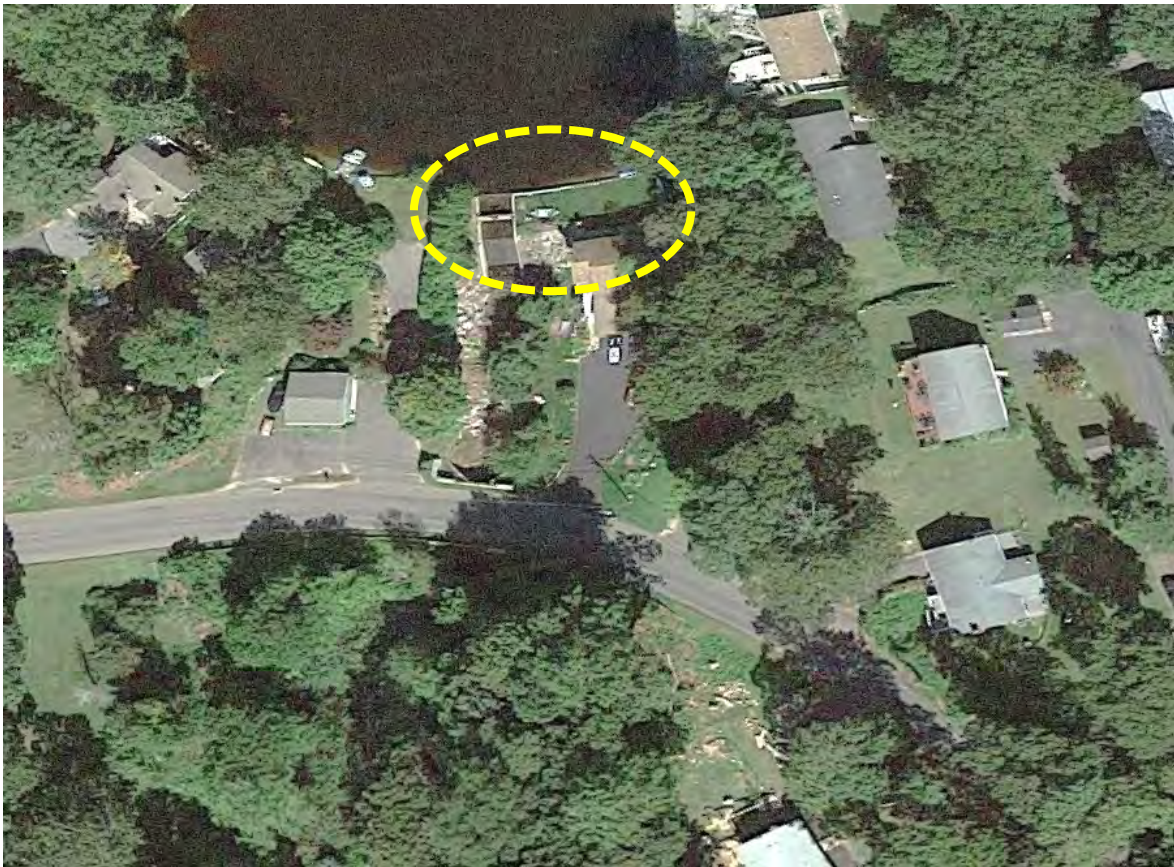
Photo 2b - Another overview from a downstream perspective, with the dam and spillway outlined in the center of the photo. [Source: Google Maps]

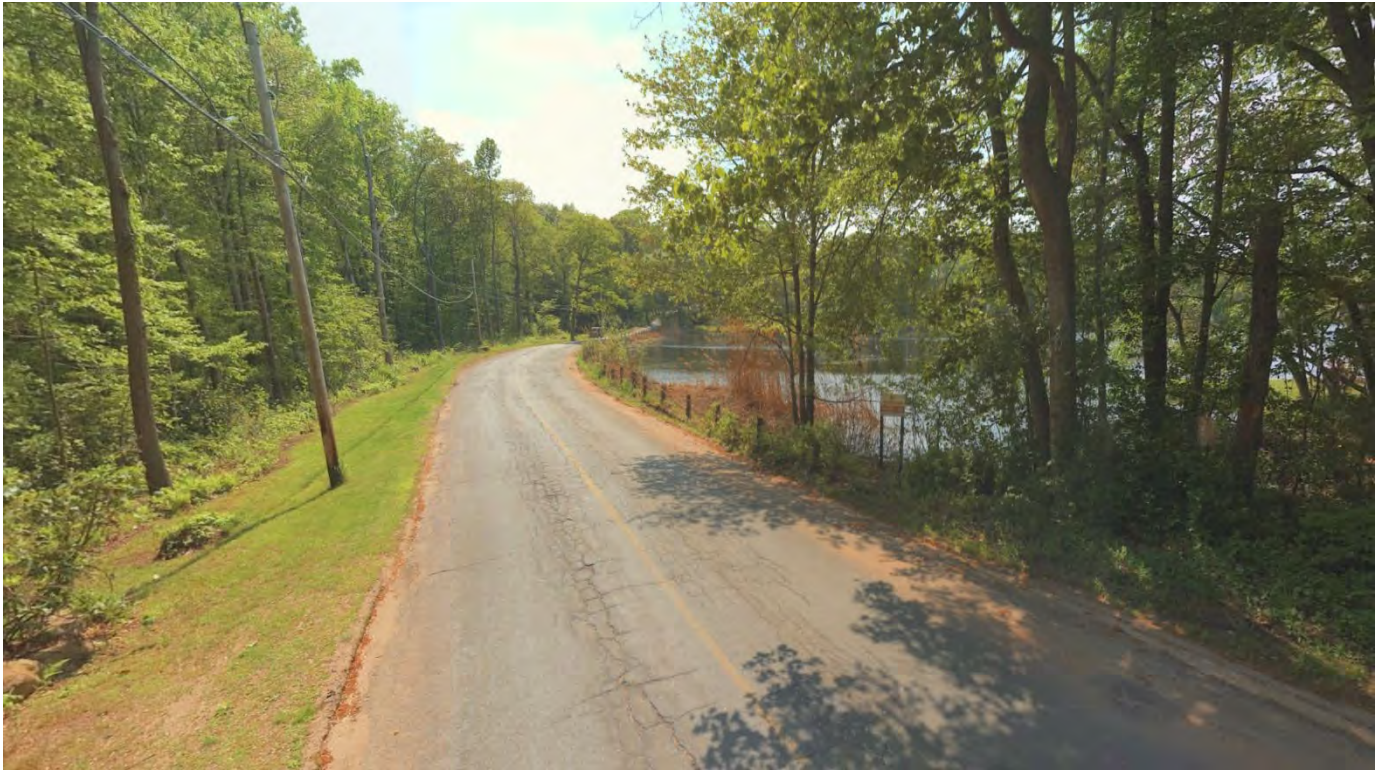
Photo 10c – The Hidden Lake Road section nominally considered the auxiliary spillway, as seen from its left side.
[Photo Source: Bing Maps]

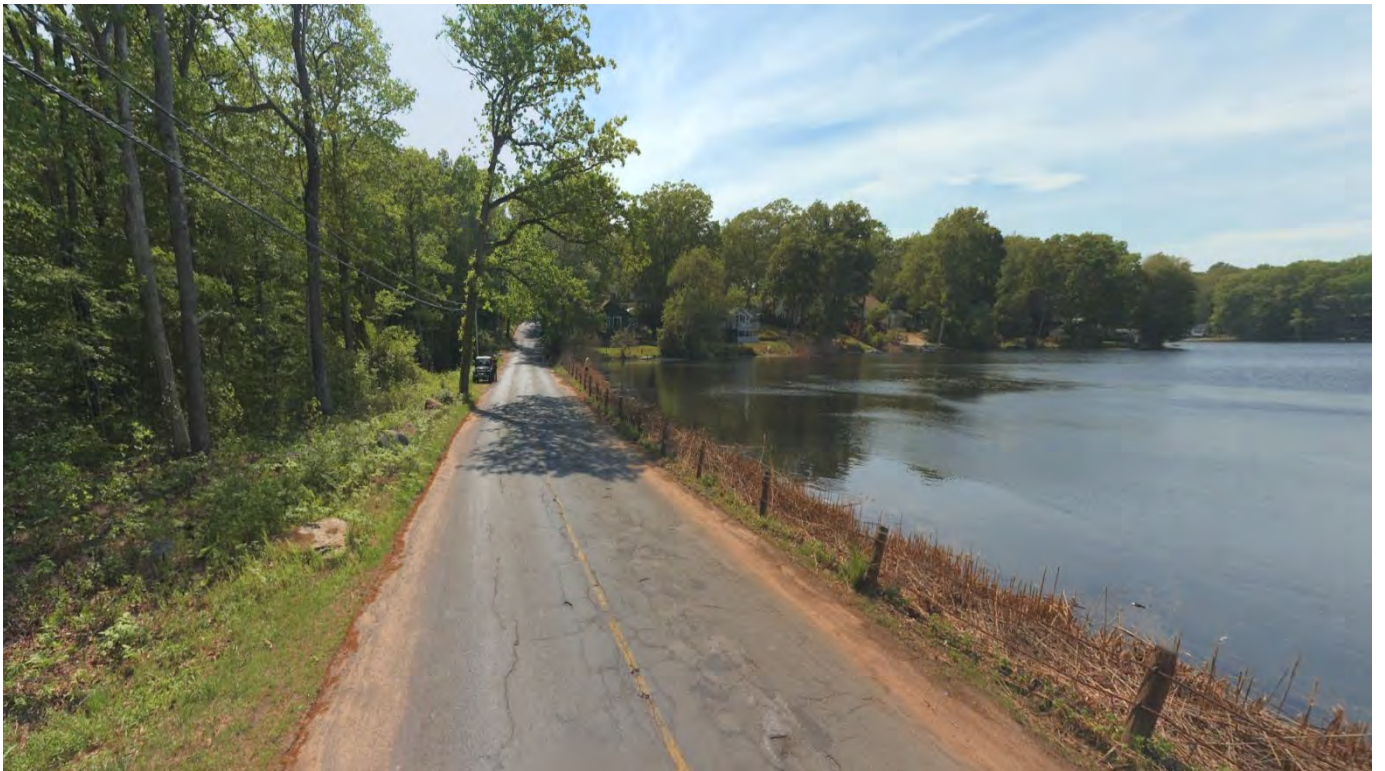
Photo 10d – Another overview of the auxiliary spillway area, looking toward its right side. See also Photo 20b for current conditions.
[Photo Source: Bing Maps]
